HARBOR HEALTH STUDY

Harbor Health Study: 2022

*The Harbor Health Study is a collaborative effort between **Harbor Watch, Copsps Island Oysters, and East Norwalk Blue** to collect data on the ecosystem health of local embayments.*

This report includes data on:

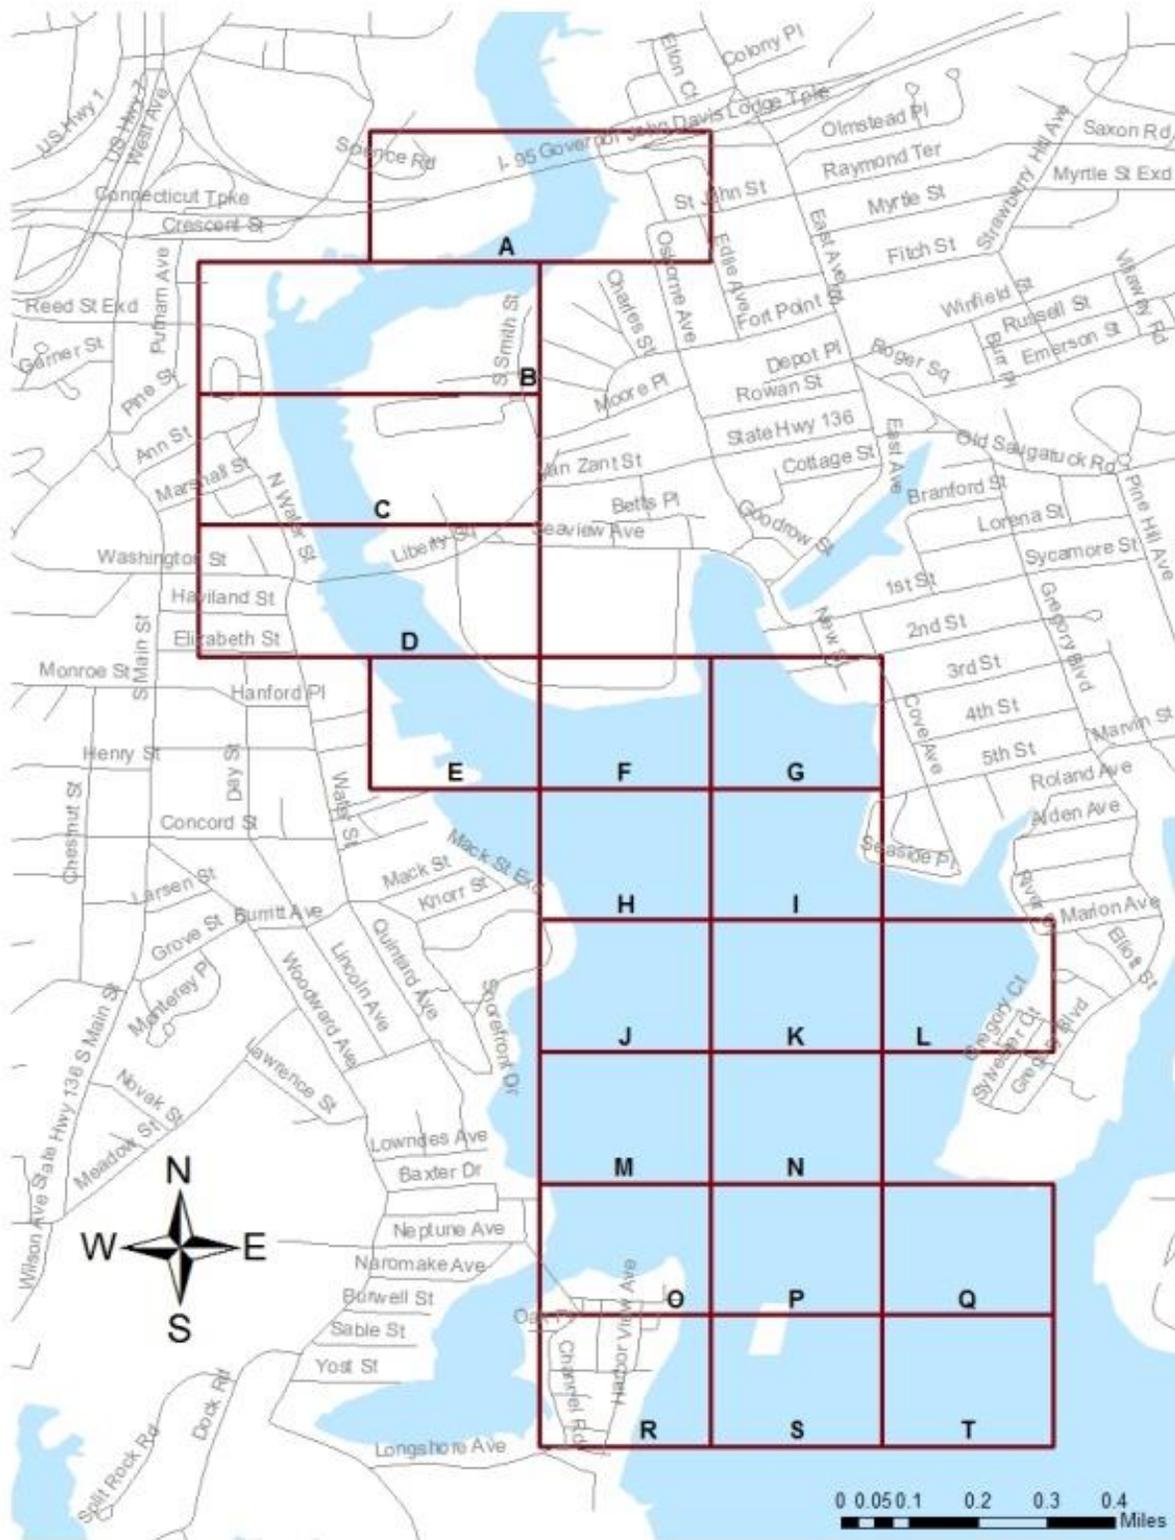
Figure 1.1. Location of trawl sampling areas or “boxes” within Norwalk Harbor.

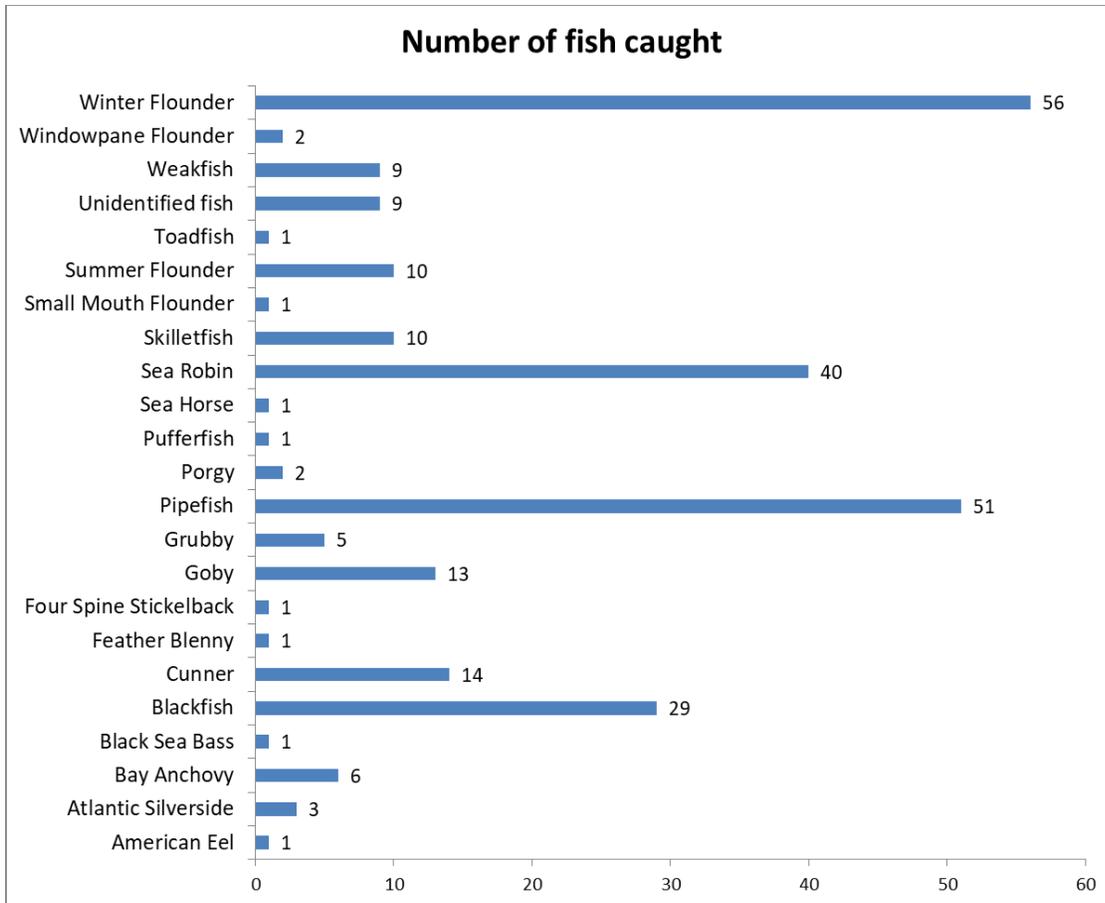
Figure 1.2. Total number of individuals caught for each species in Norwalk Harbor, May through October 2022.

During the 2022 sampling season, 267 individual fish from 22 different species were caught in Norwalk Harbor. The 3 most abundant species caught in 2022 were Winter Flounder (*Pseudopleuronectes americanus*), Pipefish (*Syngnathus spp.*), and Sea Robin (*Prionotus spp.*), which accounted for 55% of the total number of individuals (Figure 1.2). Fish were observed in all but one of the 19 boxes sampled. Box M had the greatest number of fish per trawl during 2022 with 34 individuals caught in five trawls. Three trawls were conducted outside of the predetermined boxes due to error in map interpretation of where Box O was located. Two of these trawls were conducted to the east of Box N, “East of N,” and west of Box M, “West of M”. While sampling was typically conducted in the upper, middle, and outer harbor during each trawling trip, tidal cycles impeded access to particular boxes (Table 1.1).

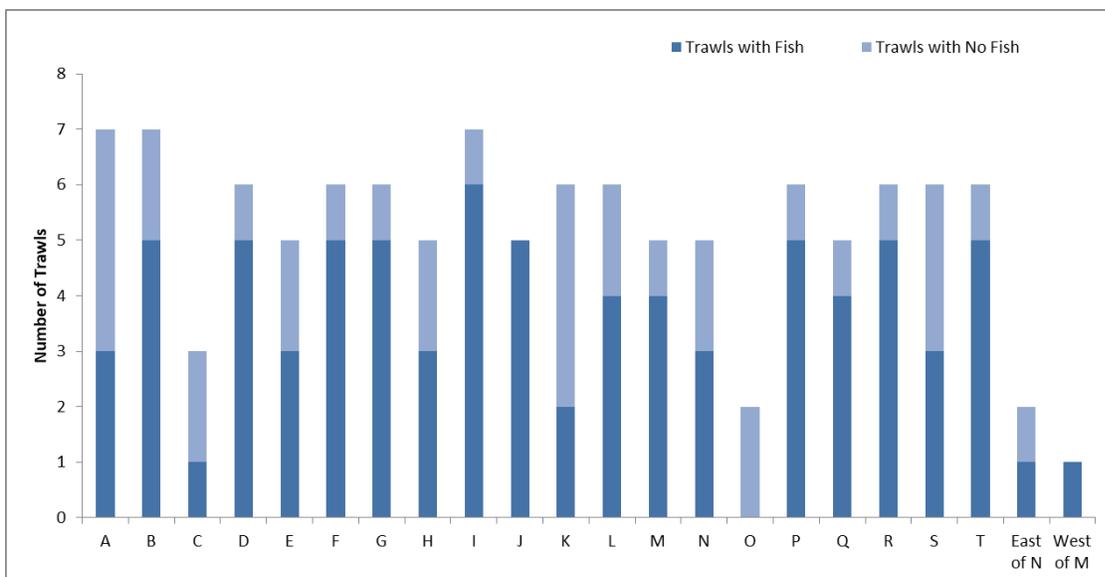
Figure 1.3. Number of trawls with fish or without fish in each “box” in Norwalk Harbor, May through October 2022.

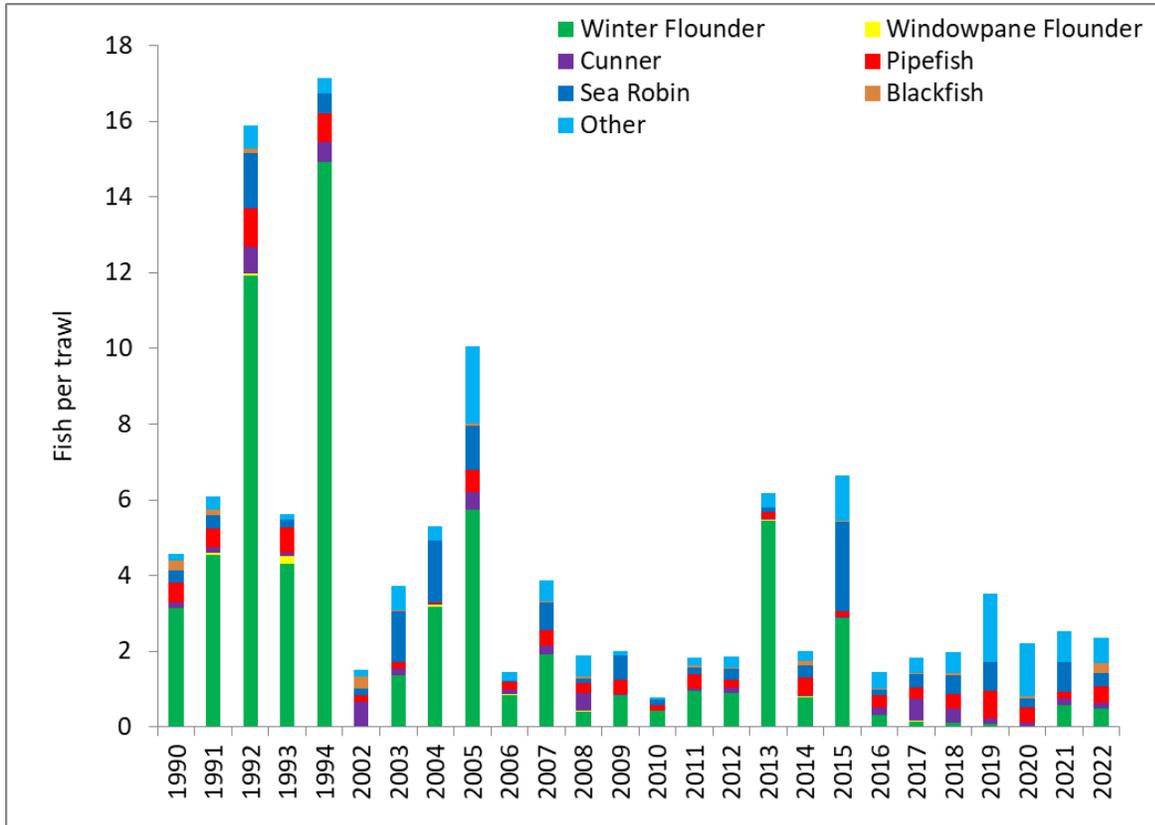
Figure 1.4. Number of fish caught per trawl (total number of individuals divided by total number of trawls) of select species of interest from 1990 to 2022 in Norwalk Harbor.

During Harbor Watch's 30 years of studying fish in the harbor, there has been a notable increase in development along the harbor banks. As a result of shoreline hardening, there has been a reduction in riparian buffer and loss of salt marshes (personal observations, R. Harris). These factors have potentially contributed to an altered composition of the benthos, from healthy microalgal populations to a silty bottom, particularly in the upper harbor. A shift in animal species found in Norwalk Harbor has also been observed. There appears to have been an increase of Canada geese, osprey, swans, and cormorants (personal observations, R. Harris). Similarly, Harbor Watch has observed changes in fish diversity since 1990 (Figure 1.4).

The overall number of fish per trawl in 2022 was 2.36 fish which was lower than fish per trawl in 2021. In 2022, 113 trawls were conducted, the highest number in a single year since the study began. Despite catching more fish in 2022 than 2021, the increase in total number of trawls drove the catch per trawl down. Potential drivers of the apparent decline in catch over time may include increasing water temperature, low dissolved oxygen values, or predation from other species inhabiting the estuary (with an observed increase in the number of cormorants; personal observation R.B. Harris). This study is expected to continue in 2023 to provide additional data to this long-term dataset.

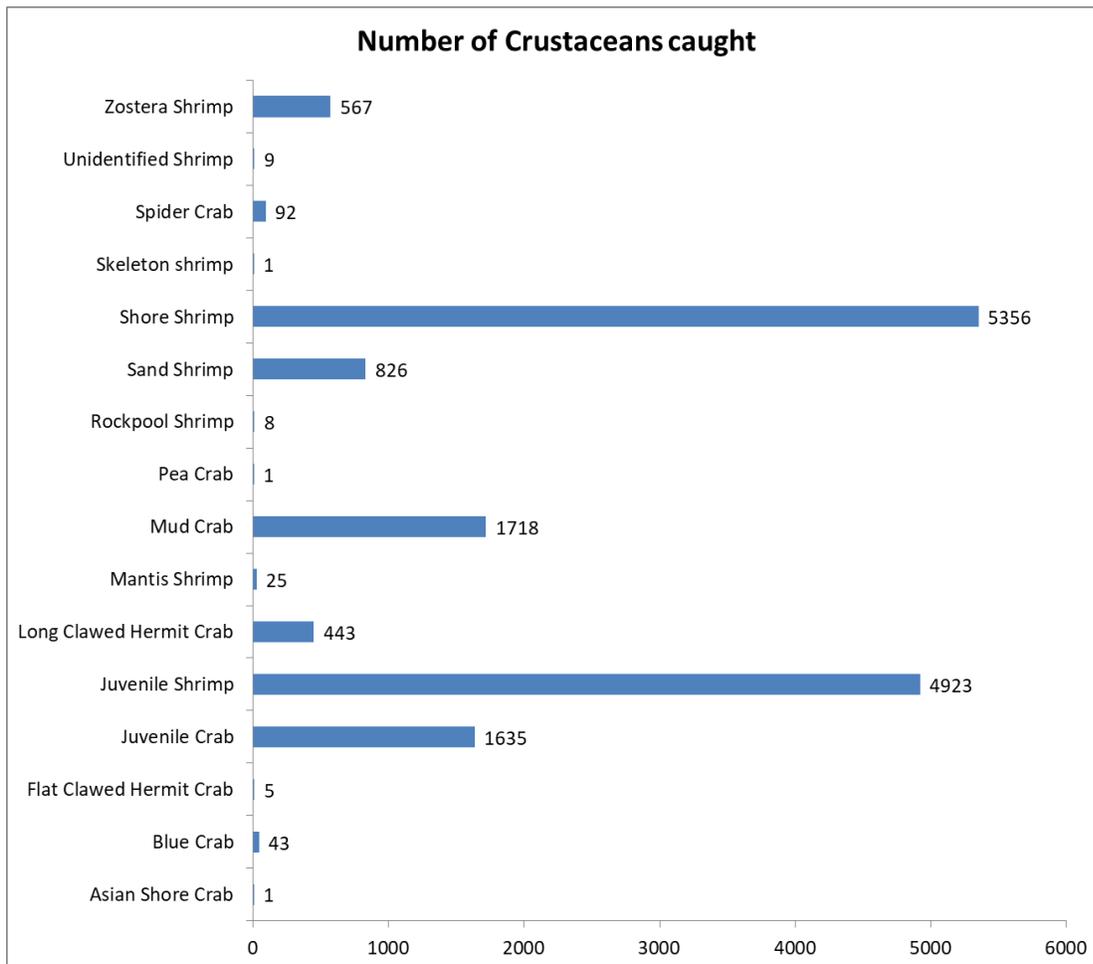
Figure 1.5. Crustaceans caught in Norwalk Harbor from May through October 2022.

In 2022, 15,653 individual crustaceans representing 13 species were observed. Certain individual crabs and shrimp were too small to confidently identify so they were documented as “Juvenile Crab” or “Juvenile Shrimp.” The catch was dominated by Shore Shrimp, Juvenile Shrimp, and Mud Crabs, accounting for approximately 77% of the total (Figure 1.5). Individual speciation for mud crabs and spider crabs was not conducted. The “Mud crab” identification represents potentially four species (*Panopeus herbsti*, *Hexapanopeus angustifrons*, *Neopanopeus sayi*, and *Eurypanopeus depresssus*) but was likely dominated by black fingered mud crab (*Panopeus herbsti*). The “Spider crab” identification represents potentially two species (*Libinia emarginata* and *Libinia dubia*) but was likely dominated by the nine-spined spider crab (*Libinia emarginata*). Additional notable catches include the rock pool shrimp (*Palaemon elegans*), which have not been previously caught in Harbor Watch’s trawls, but have been seen in nearby harbors by Richard Harris, as well as the Zostera Shrimp (*Hippolyte zostericola*) which have not been previously caught in Harbor Watch trawls and do not appear to have been observed in Norwalk Harbor by other community partners.

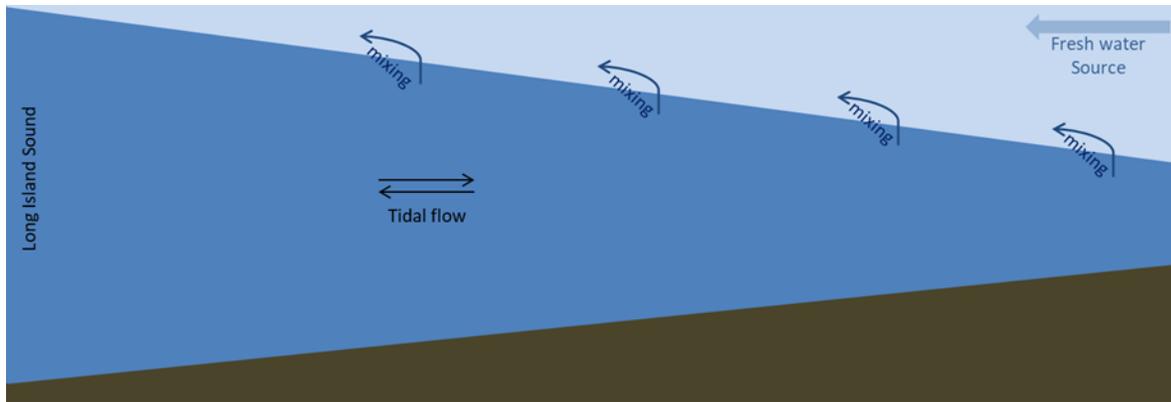
Figure 2.1. Sketch of estuary tidal wedge, water flow, and water column mixing.

The harbors monitored in this study are estuaries, which are marine embayments with a freshwater source resulting in brackish water. The mixing of these freshwater and saltwater sources in many harbors consists of a "tidal wedge" (Figure 2.1), which is comprised of salt water underlying a freshwater surface layer, which is usually incoming water from a river. The more dense salt water layer oscillates laterally within the harbor in response to the semidiurnal tides. Because of this density-driven stratification within estuaries, the bottom water often becomes depleted of dissolved oxygen when exposed to oxygen demanding (reducing) bottom sediments and poor flushing. As fresh water moves seaward above the tidal wedge, salt water is entrained in the freshwater layer, reducing the stratification. This mixing of fresh and salt water occurs along the length of a harbor, with the salinity of the surface layer increasing as the distance from the freshwater source increases. Mixing of the salt water from the tidal wedge (Figure 2.1) causes a fresh flow of marine water to enter from the mouth of the estuary, bringing nutrients and oxygen with it.

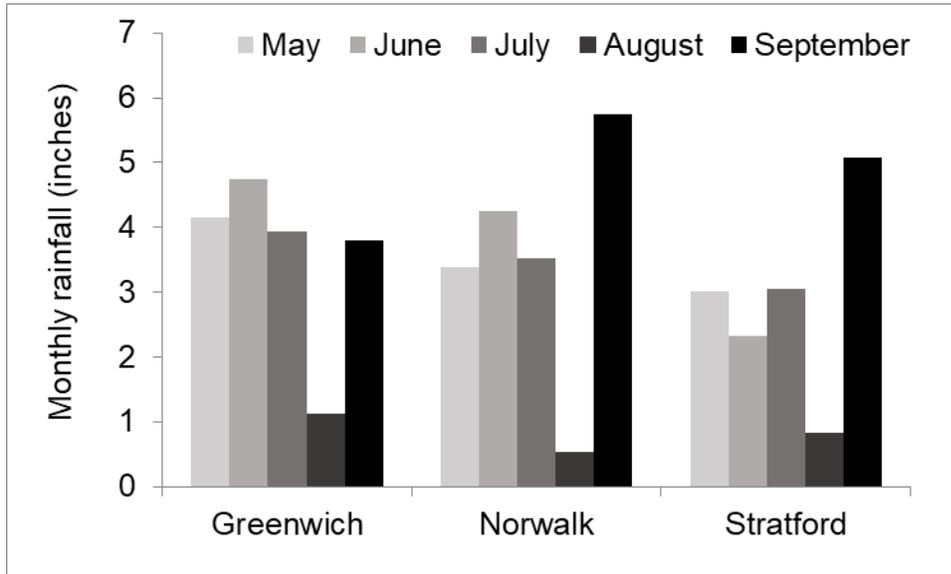
Figure 2.2. 2022 monthly rainfall totals for each geographical area monitored (Greenwich Town Hall Rain Gauge, Norwalk Health Department Rain Gauge, Sikorsky Memorial Airport Rain Gauge).

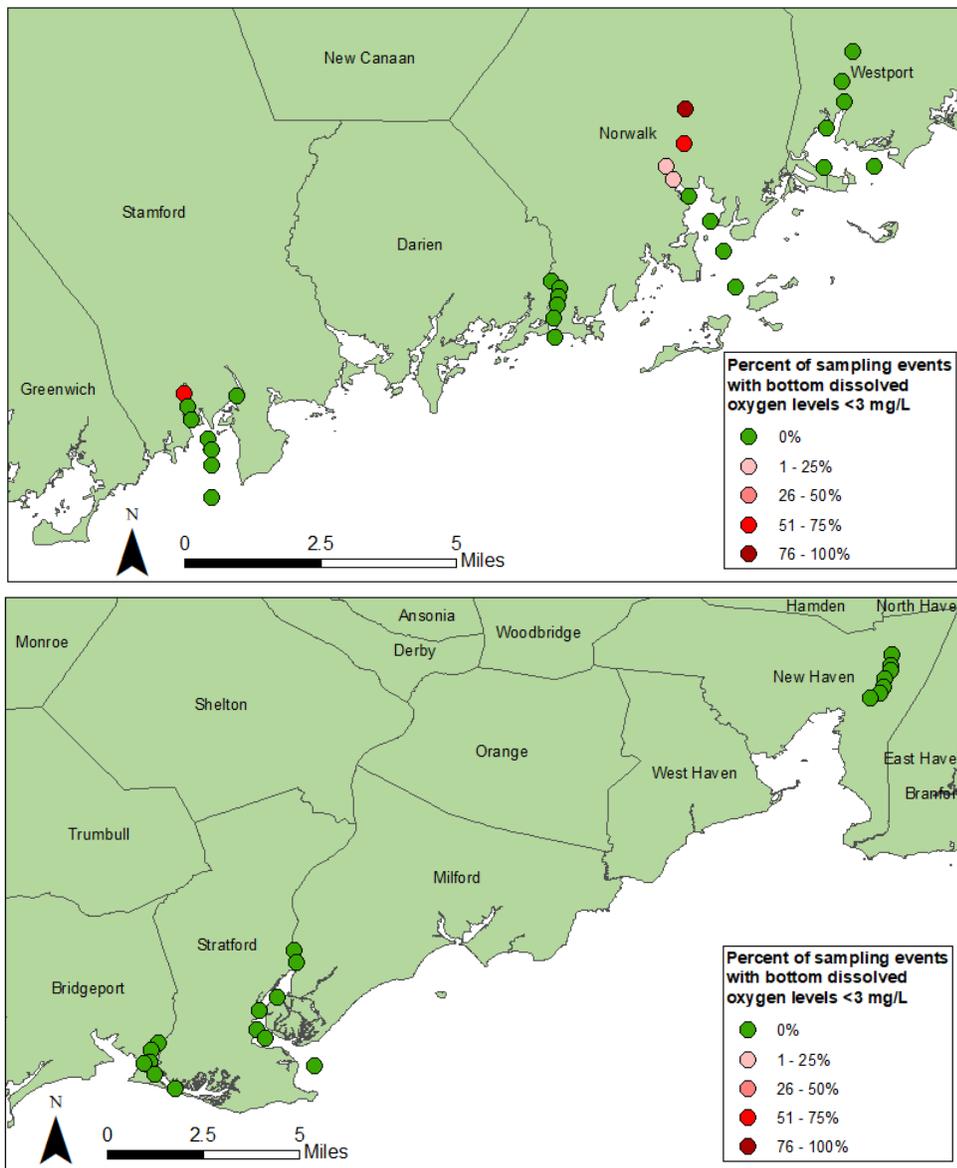
Figure 2.3. Percentage of water column readings where dissolved oxygen values fell below 3 mg/L in 2022 in the western harbors (top) and the eastern harbors (bottom).

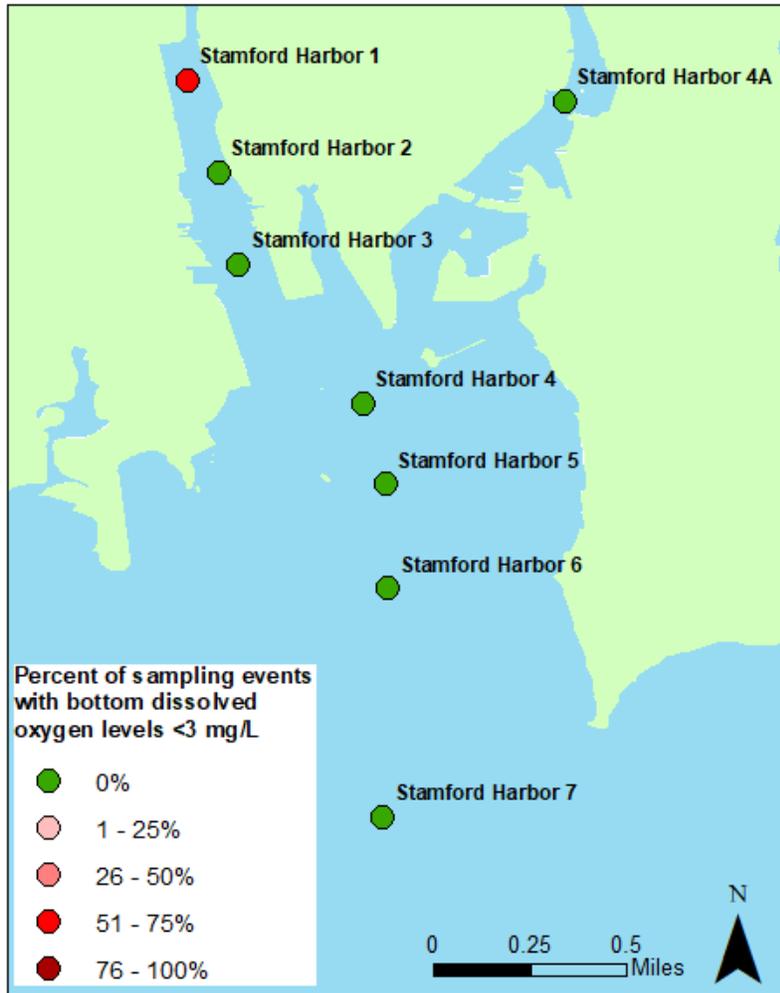
Figure 2.A.2. Map of Stamford Harbor sampling stations for 2022. Color of dots represents the percent of sampling events with dissolved oxygen levels less than 3 mg/L.

Profiles of the water column were taken at 8 sites along the length of the Harbor (Figure 2.A.2, Table 2.A.1). Sampling occurred on 5 days during the monitoring season from July through September. Mean dissolved oxygen values in Stamford Harbor ranged from a minimum of 3.02 mg/L on the bottom at Stamford Harbor 1 to a maximum of 6.79 mg/L on the surface at Stamford Harbor 6 (Figure 2.A.3). Forty-three percent of the bottom dissolved oxygen concentrations observed were less than 5 mg/L, and 8% were less than 3 mg/L (hypoxic).

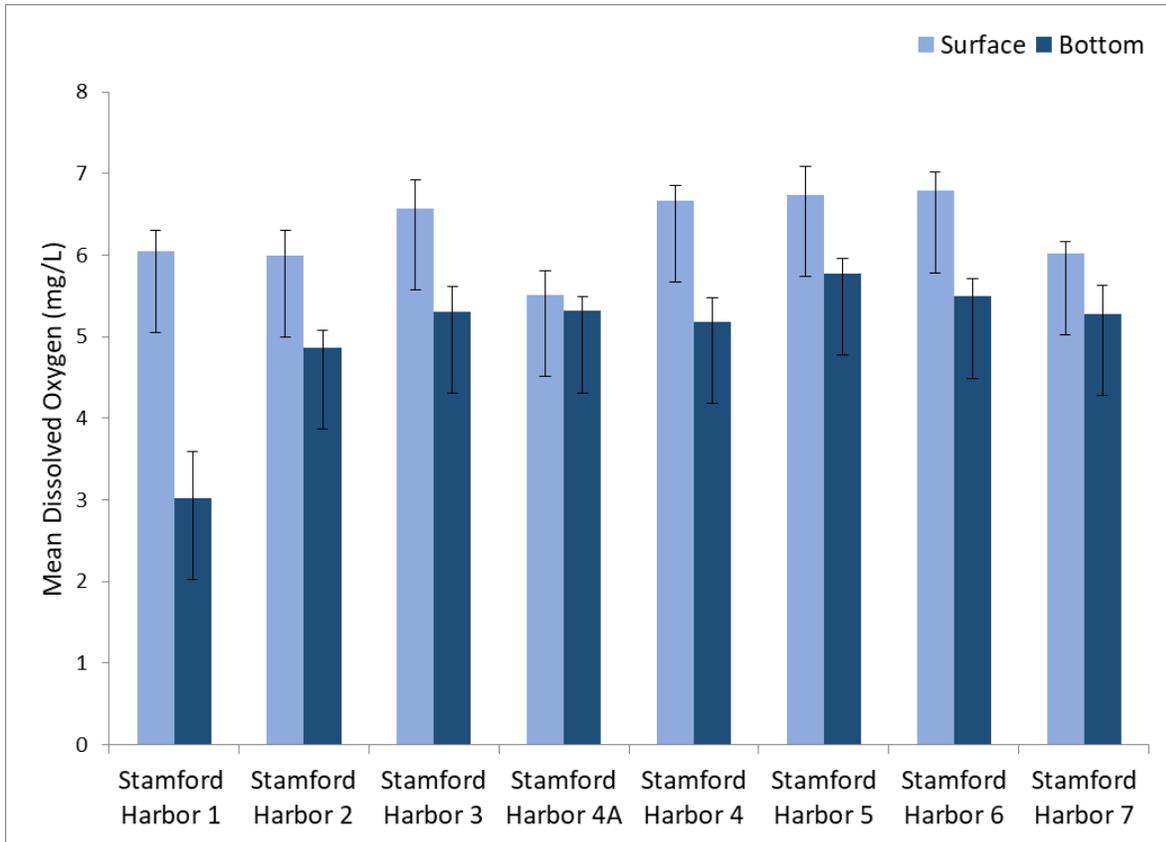
Figure 2.A.3. Mean dissolved oxygen concentrations at the surface and bottom at each sampling station in Stamford Harbor in 2022. Error bars represent standard error.

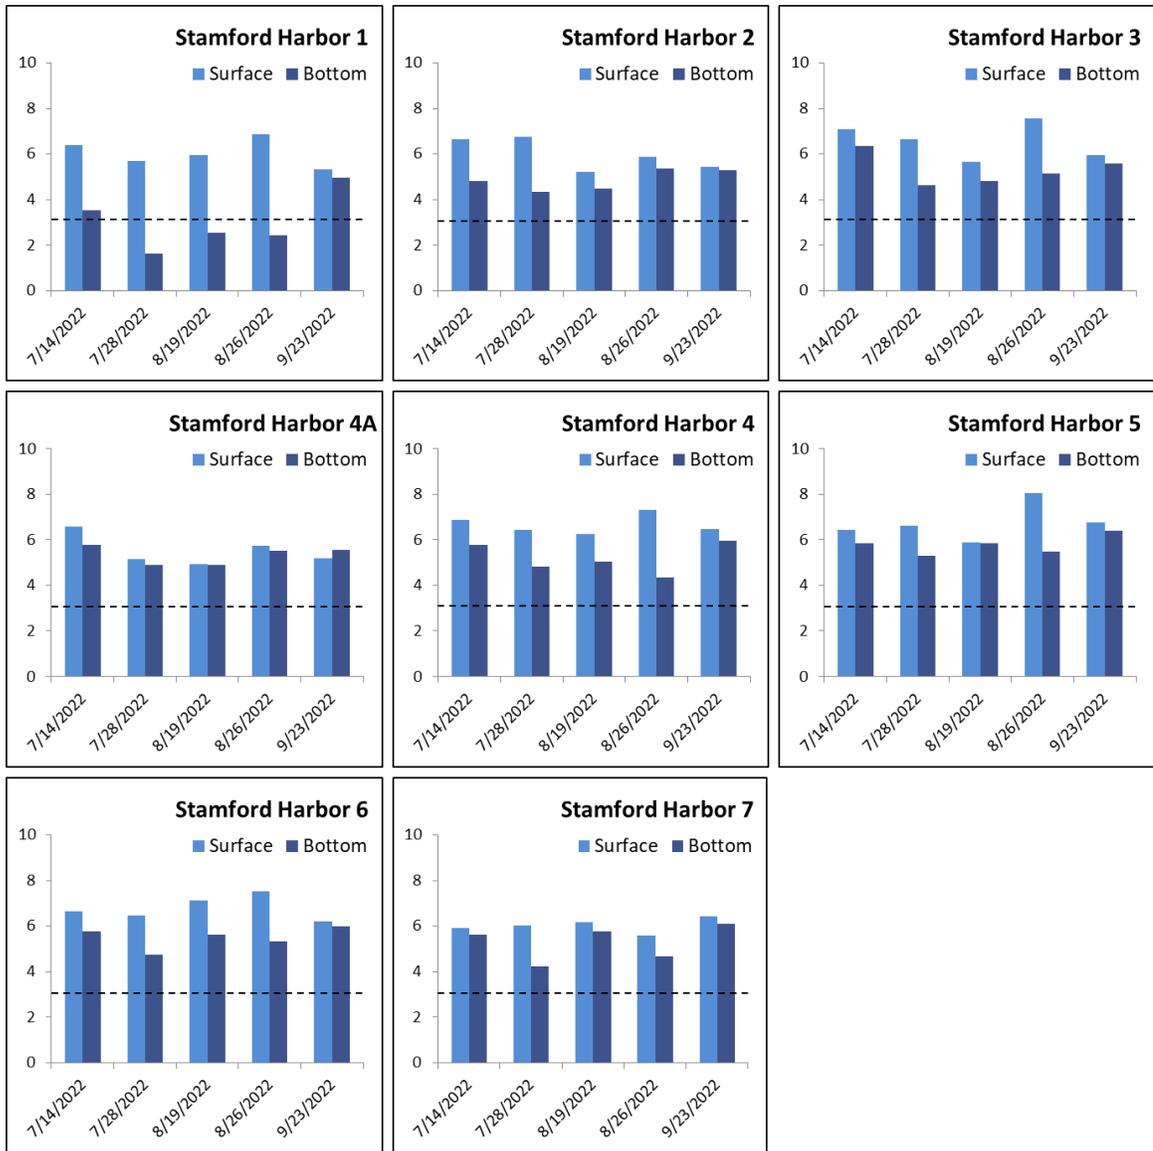
Figure 2.A.4. Surface and bottom dissolved oxygen values at each Stamford Harbor sampling station on each monitoring date during the 2022 season. The dotted line represents hypoxic conditions (3 mg/L). Please note x-axis is not to scale.

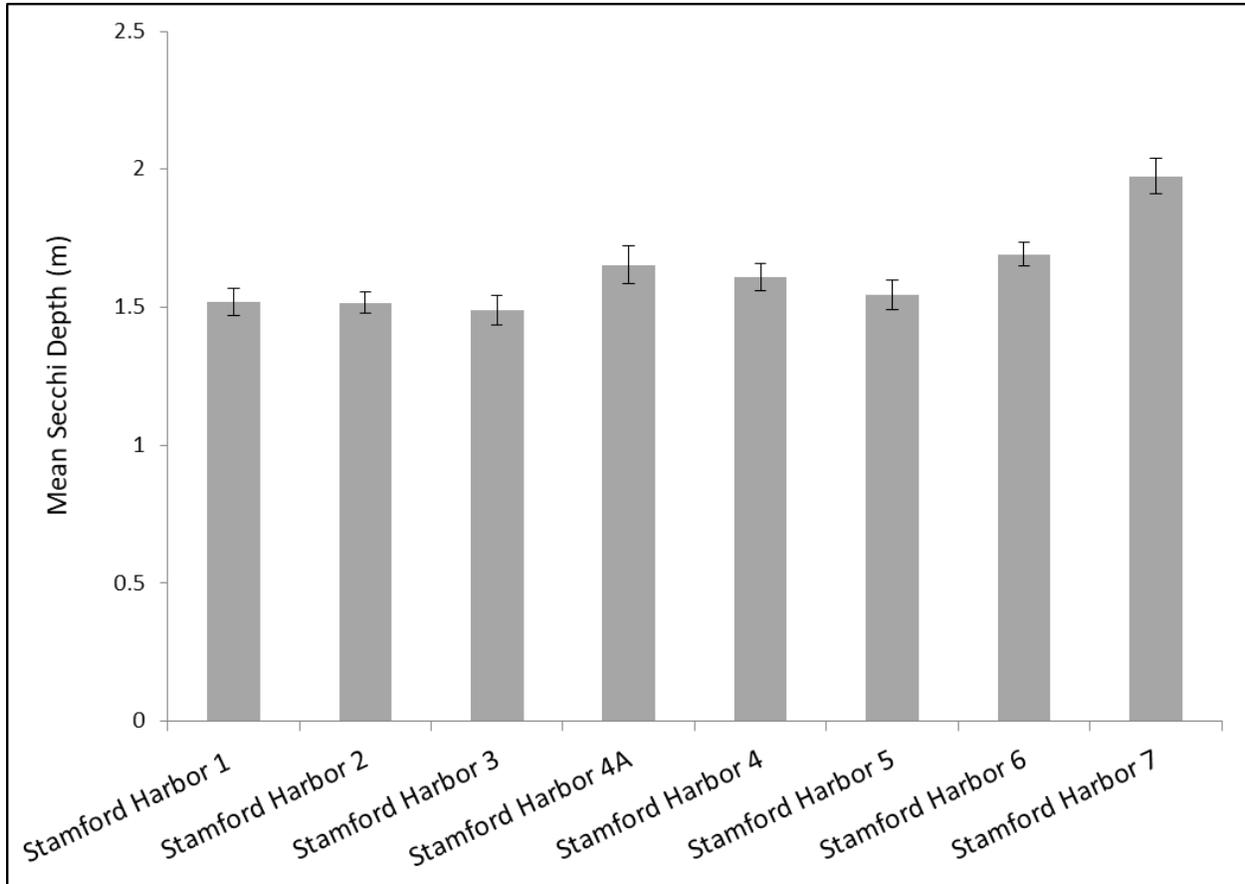
Figure 2.A.6. Mean secchi depth readings in Stamford Harbor in 2022. Error bars represent standard error.

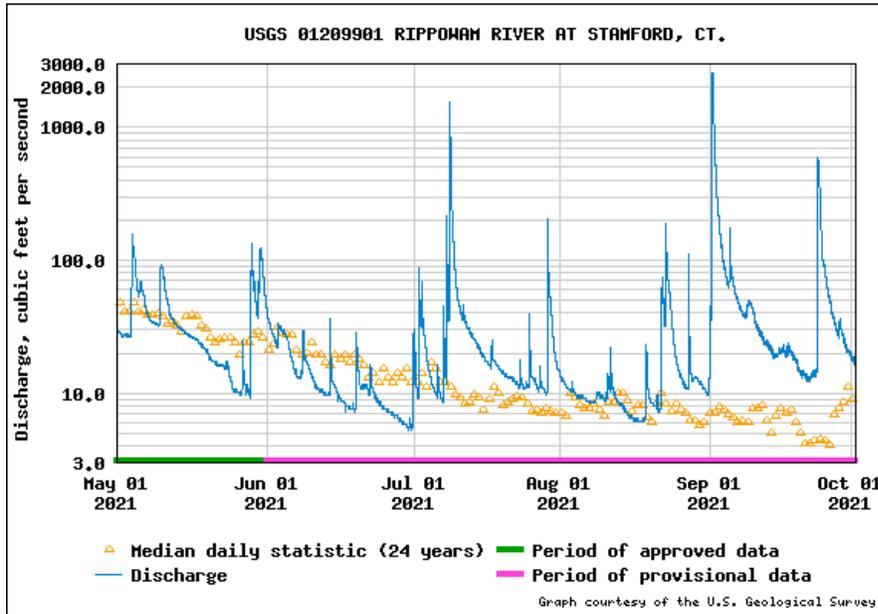
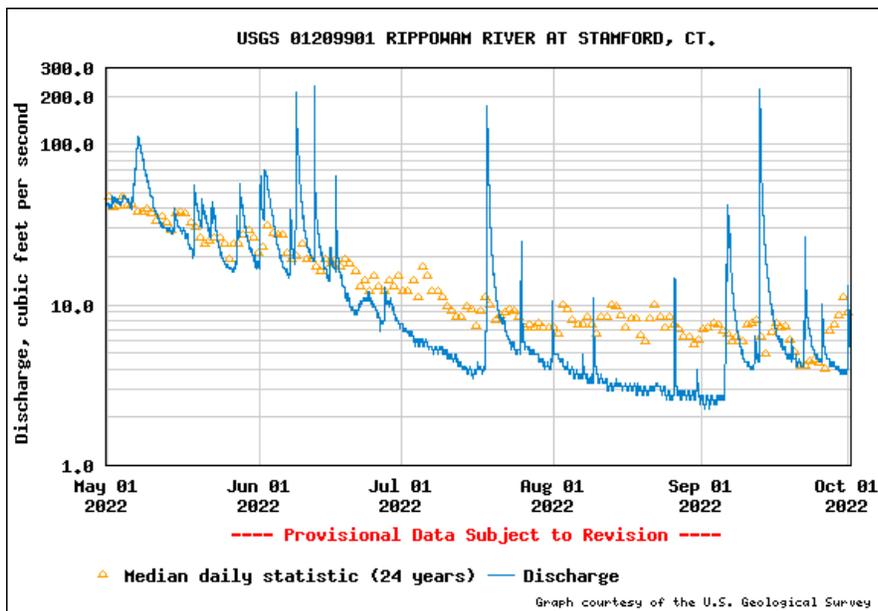
Figure 2.A.7. USGS flow data in ft^3/s for the period of May 1 through October 1, 2021 (top) and 2022 (bottom) for the Rippowam River near Stamford, CT (Graphs courtesy of the U.S. Geological Survey). Please note the difference in scale on the y-axis.

The figures below illustrate discharge in cubic feet per second recorded at the United States Geological Survey (USGS) monitoring station on the Rippowam River in Stamford, CT. Yellow triangles represent the daily median value over the last 24 years, and the blue line represents the recorded discharge for a particular date. In the summer of 2021, discharge was observed to be higher than was observed in 2022.

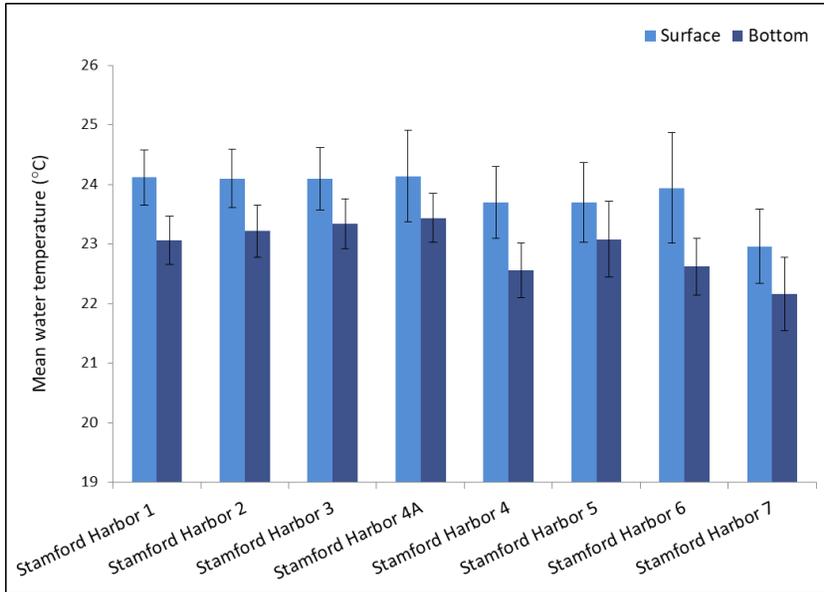
Figure 2.A.8. Mean water temperature at the surface and bottom at each sampling station in Stamford Harbor in 2022. Error bars represent standard error.

Mean temperature differences observed between the surface and the bottom were similar throughout the harbor (Figure 2.A.8). Lower surface salinity at station Stamford Harbor 4A is likely a result of constant fresh water flow of treated sewage effluent, estimated at 24 million gallons per day, to the east branch (Figure 2.A.9).

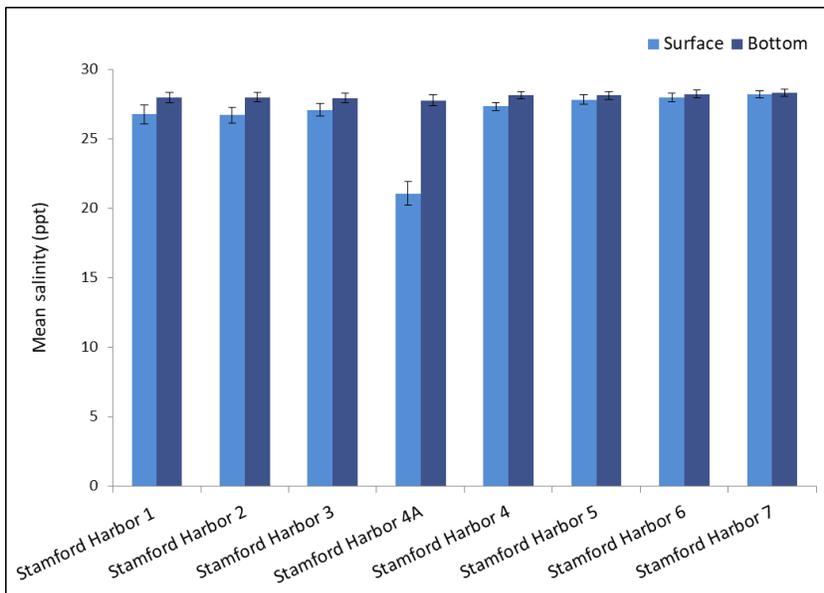
Figure 2.A.9. Mean salinity at the surface and bottom at each sampling station in Stamford Harbor in 2022. Error bars represent standard error.

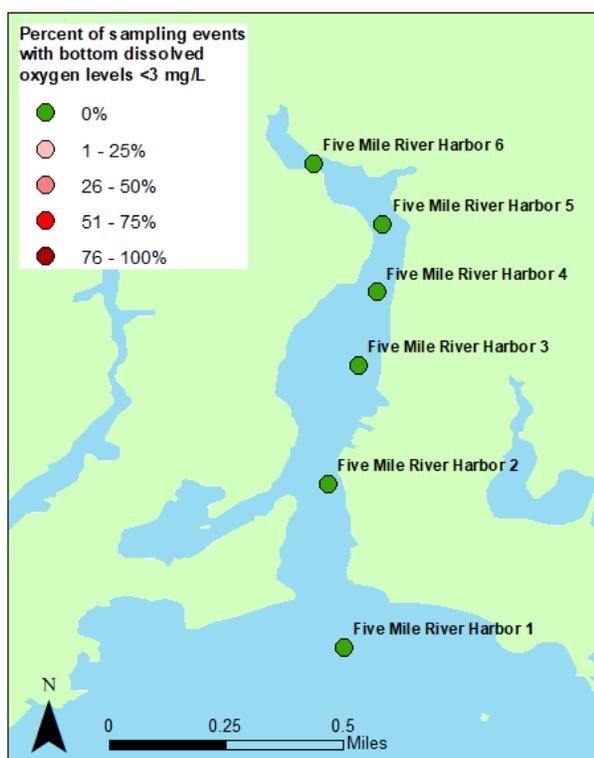
Figure 2.B.1. Map of Five Mile River Harbor sampling stations. Color of dots represents the percent of sampling events with dissolved oxygen levels less than 3 mg/L in 2022.

Mean surface and bottom water temperature in Five Mile River Harbor were similar throughout the harbor (Figure 2.B.7). Lower salinity observed at the surface in the landward end of the estuary reflects the impact of Five Mile River input from the north and Indian Creek input upstream of Five Mile Harbor 5, where the harbor is less well mixed (Figure 2.B.1, Figure 2.B.8).

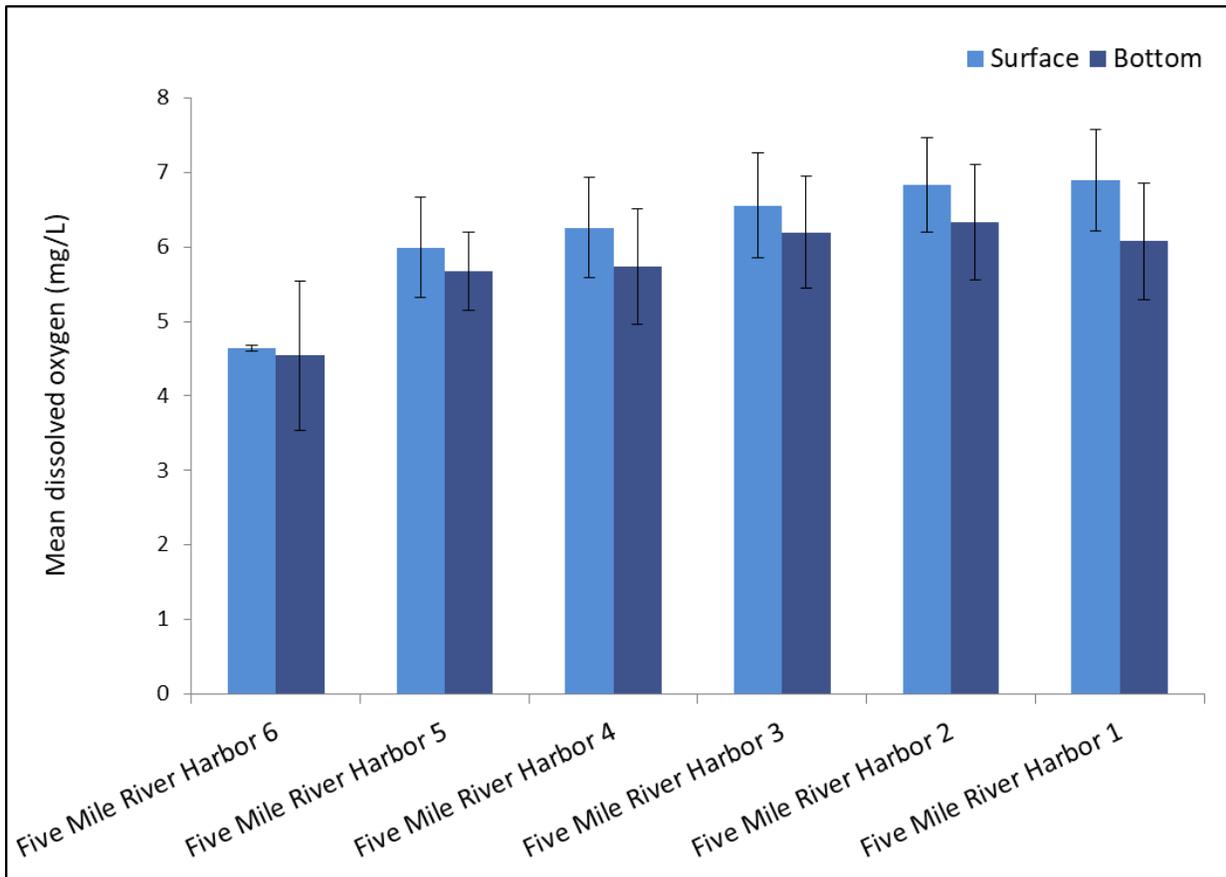
Figure 2.B.2. Mean dissolved oxygen concentrations at the surface and bottom at each sampling station in Five Mile River Harbor in 2022. Error bars represent standard error.

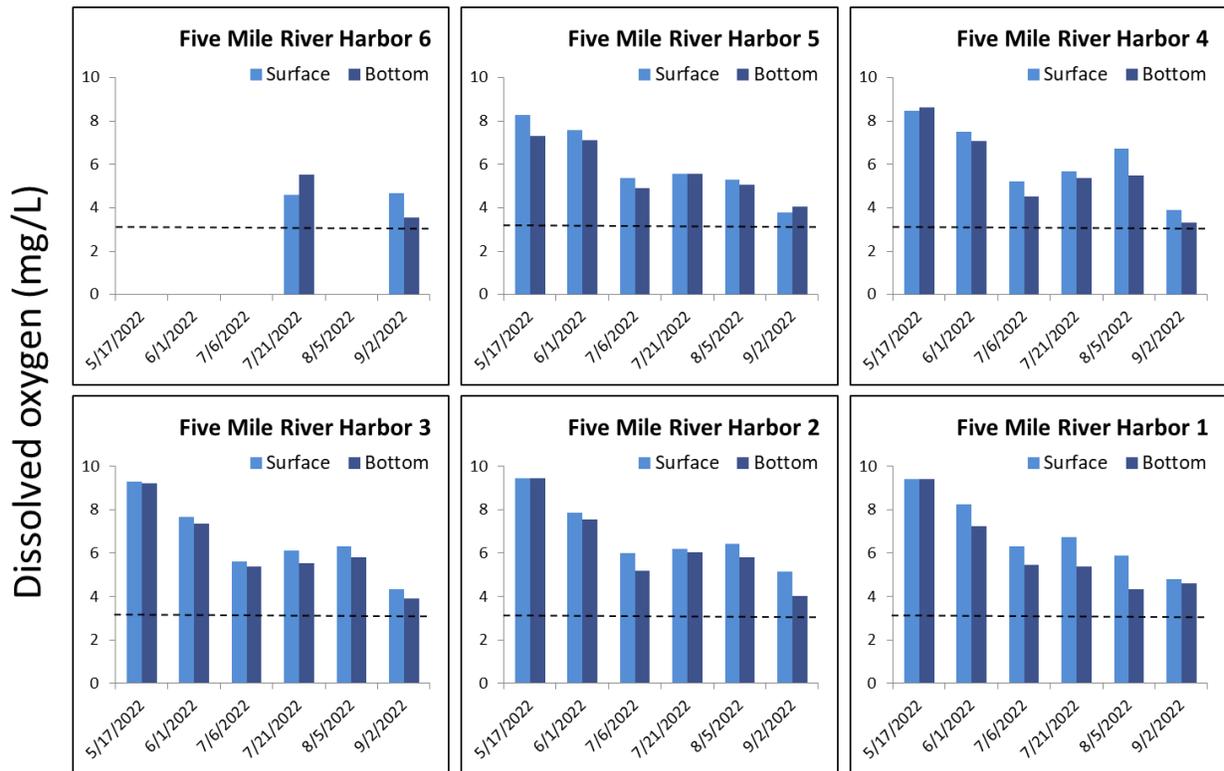
Figure 2.B.3. Surface and bottom dissolved oxygen values at each Five Mile River Harbor sampling station on each monitoring date during the 2022 season. The dotted line represents hypoxic conditions (3 mg/L). Station Five Mile River Harbor 6 was sampled only on 7/21/2022 and 9/2/2022 due to inaccessibility. Please note x-axis is not to scale.

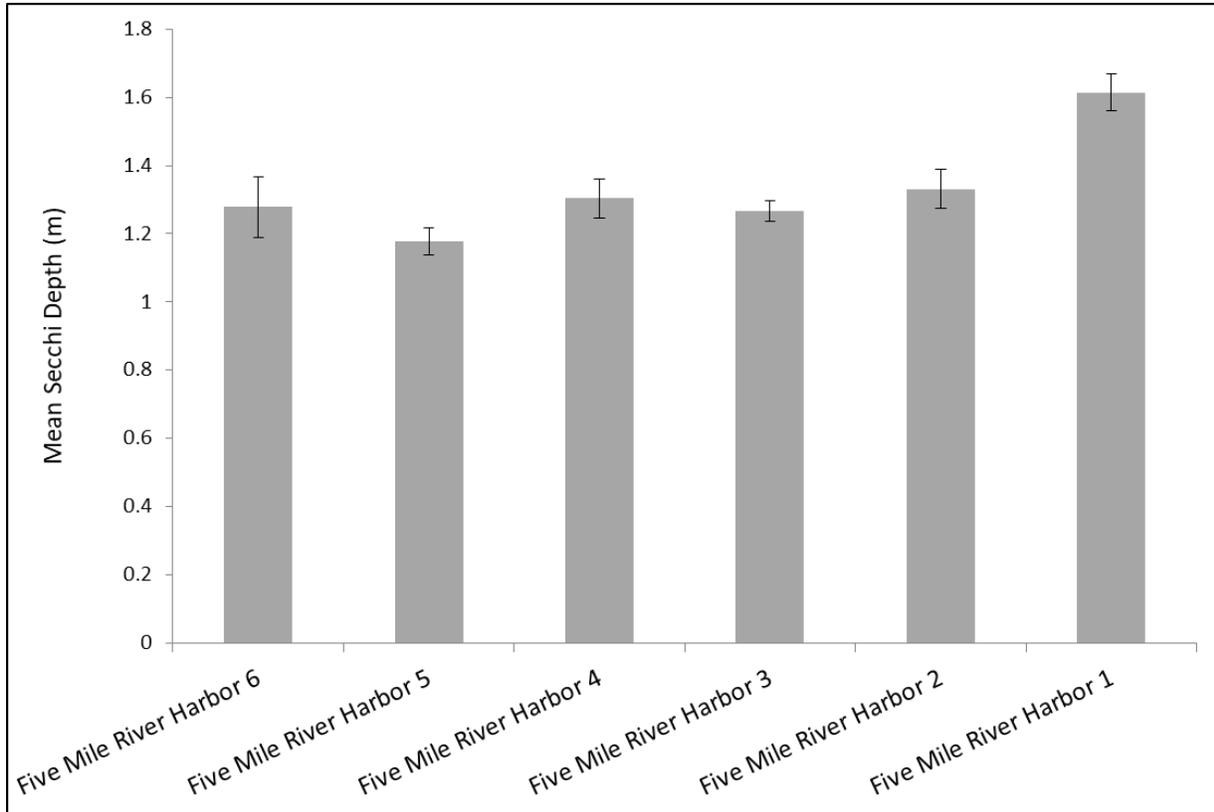
Figure 2.B.5. Mean secchi depth readings in Five Mile River Harbor in 2022. Error bars represent standard error.

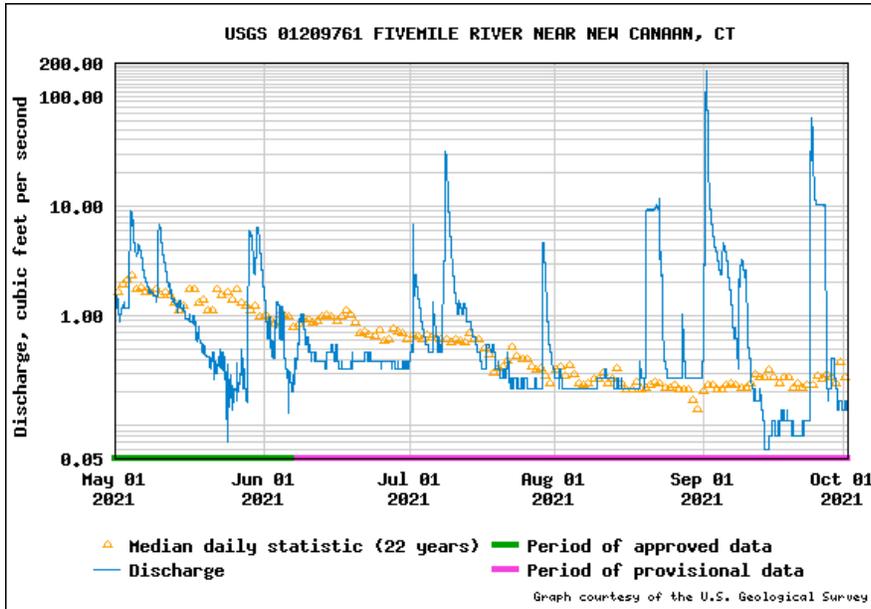
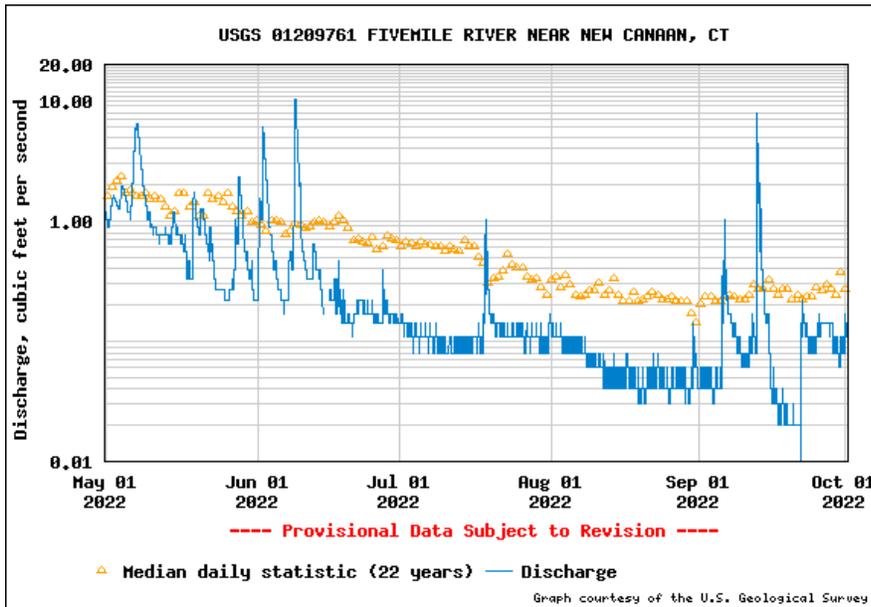
Figure 2.B.6. USGS flow data in ft^3/s for the period of May 1 through October 1, 2021 (top) and 2022 (bottom), respectively for the Five Mile River in New Canaan, CT (Graph courtesy of the U.S. Geological Survey). Please note the difference in scale on the y-axis.

The figures below illustrate discharge rates recorded at the United States Geological Survey monitoring station on the Five Mile River in New Canaan, CT. Yellow triangles represent the daily median value over the last 22 years, and the blue line represents the recorded discharge for a particular date. In 2021, frequent rain events increased discharge frequently from May through October while discharge was observed to be much lower in 2022, and often below the median.

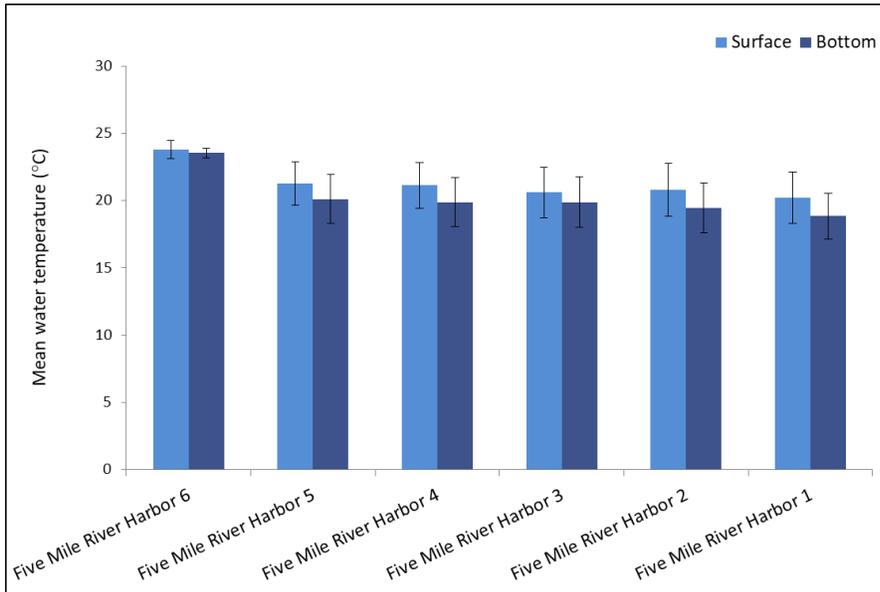
Figure 2.B.7. Mean water temperature at the surface and bottom at each sampling station in Five Mile River Harbor in 2022. Error bars represent standard error.

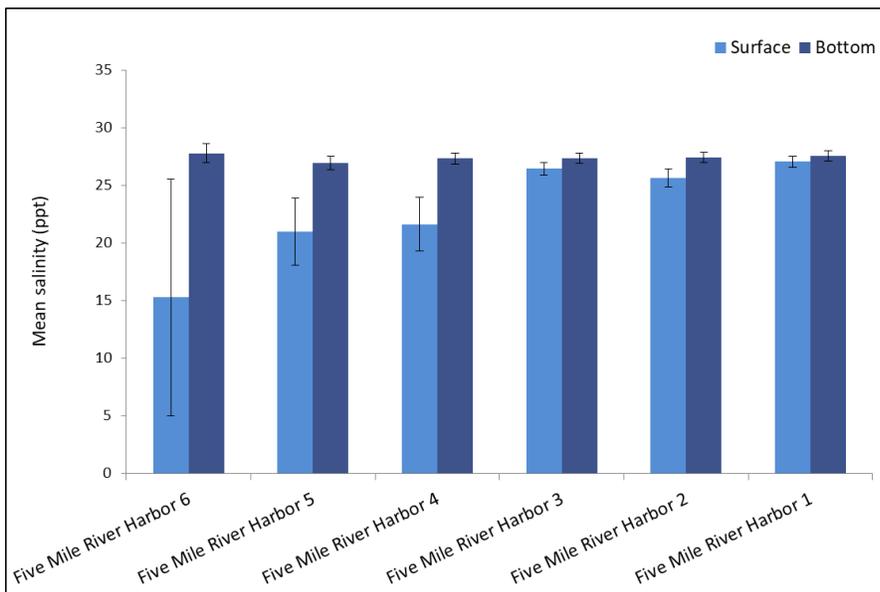
Figure 2.B.8. Mean salinity at the surface and bottom at each sampling station in Five Mile River Harbor in 2022. Error bars represent standard error.
