HARBOR HEALTH STUDY

Harbor Health Study: 2022

*The Harbor Health Study is a collaborative effort between **Harbor Watch, Copsps Island Oysters, and East Norwalk Blue** to collect data on the ecosystem health of local embayments.*

This report includes data on:

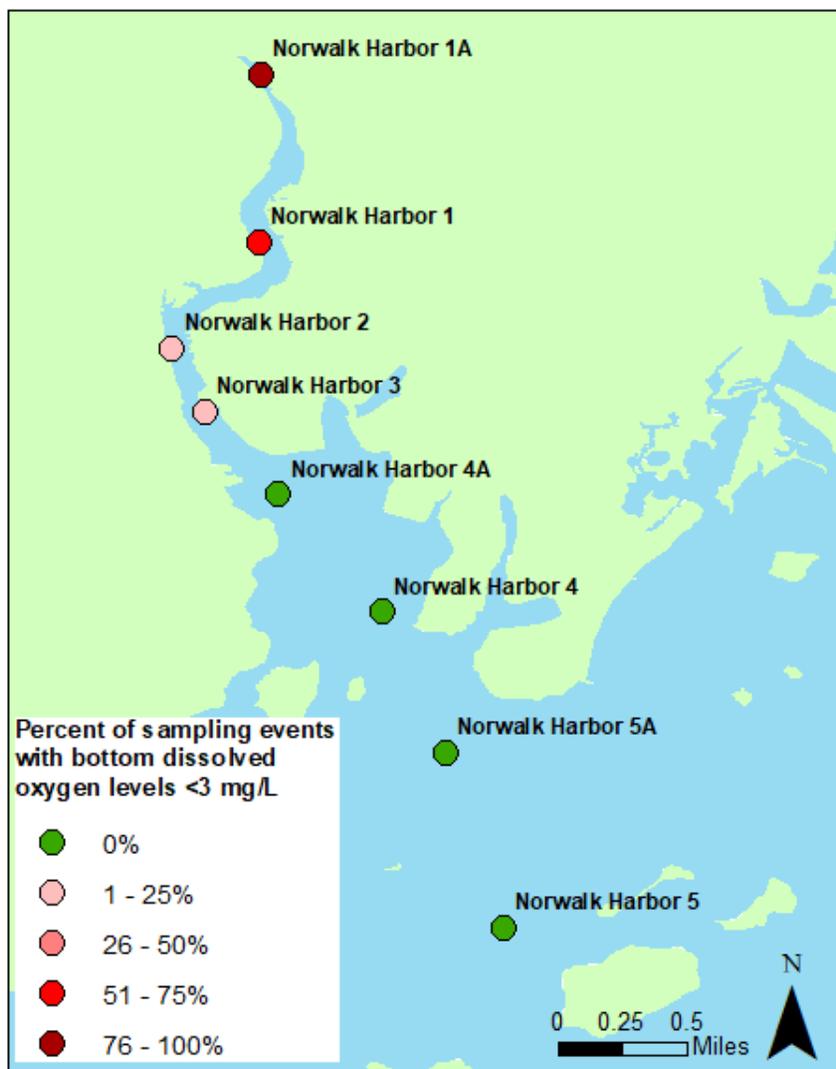
Figure 2.C.2. Map of Norwalk Harbor sampling stations in the inner harbor for 2022. Color of dots represents the percent of sampling events with dissolved oxygen levels less than 3 mg/L.

Norwalk Harbor, located in Norwalk, CT, is fed with fresh water from the Norwalk River. Of the harbors monitored in this report, the Norwalk Harbor is the only one which does not have a tidal basin which could aid in flushing at ebb tide. The harbor once had extensive wetlands on both shorelines (Figure 2.C.1) which have now been filled in or removed and replaced with hardened shoreline to accommodate the many industrial and commercial businesses located along the shores. Land use around the edges of the harbor includes landfills, marinas, and housing developments ranging from high density apartments to single-family homes. This report will discuss the inner harbor, which includes the length of the estuary from Wall Street to the Norwalk Islands (Figure 2.C.2).

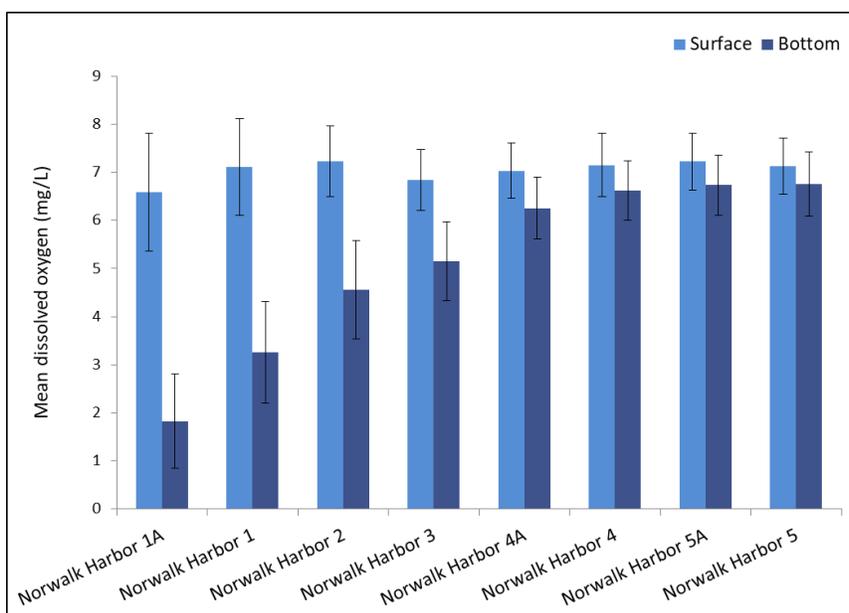
Figure 2.C.3. Mean dissolved oxygen concentrations at the surface and bottom at each sampling station in Norwalk Harbor during 2022. Error bars represent standard error.

Wide ranges in dissolved oxygen concentrations at the surface and bottom were observed in most of the upstream sampling locations (Figure 2.C.3, Figure 2.C.4). At the sampling locations further seaward, the differences in dissolved oxygen concentrations were smaller, presumably from the larger width of the harbor and increased mixing reducing stratification. The upper 3 stations, Norwalk Harbor 1A, Norwalk Harbor 1, and Norwalk Harbor 2, likely had a highly stratified water column throughout the season based on limited mixing time with the flow of fresh water entering the harbor from the Norwalk River (Figure 2.C.3, Figure 2.C.9). Station Norwalk Harbor 1A was the most impaired water in the harbor for dissolved oxygen, consistent with past years.

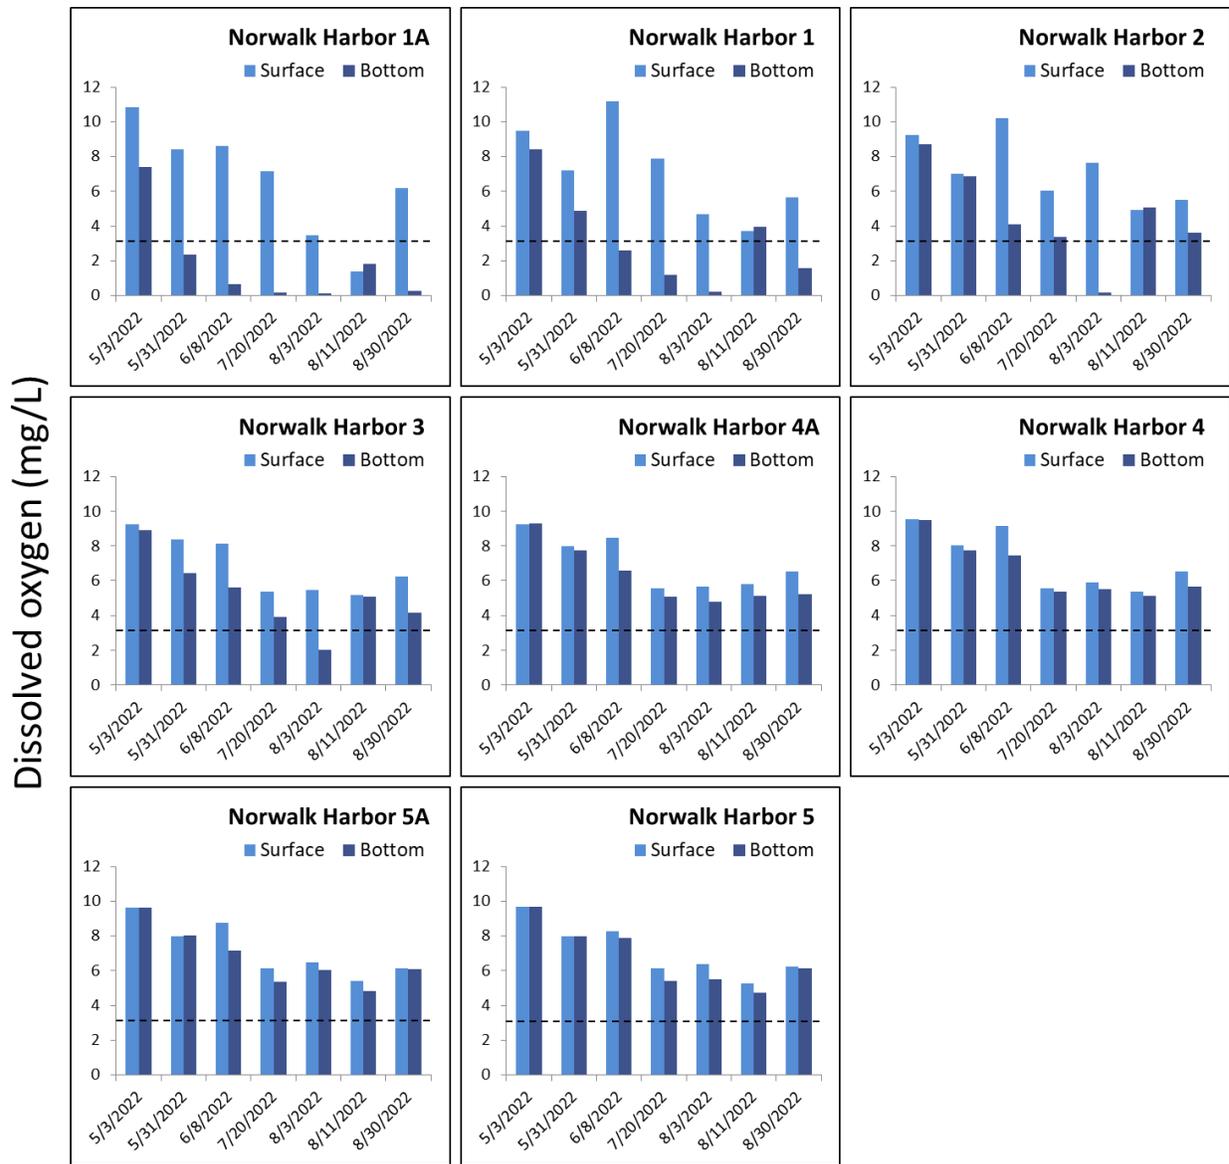
Figure 2.C.4. Surface and bottom dissolved oxygen values at each Norwalk Harbor sampling station on each monitoring date during the 2022 season. The dotted line represents hypoxic conditions (3 mg/L). Please note x-axis is not to scale.

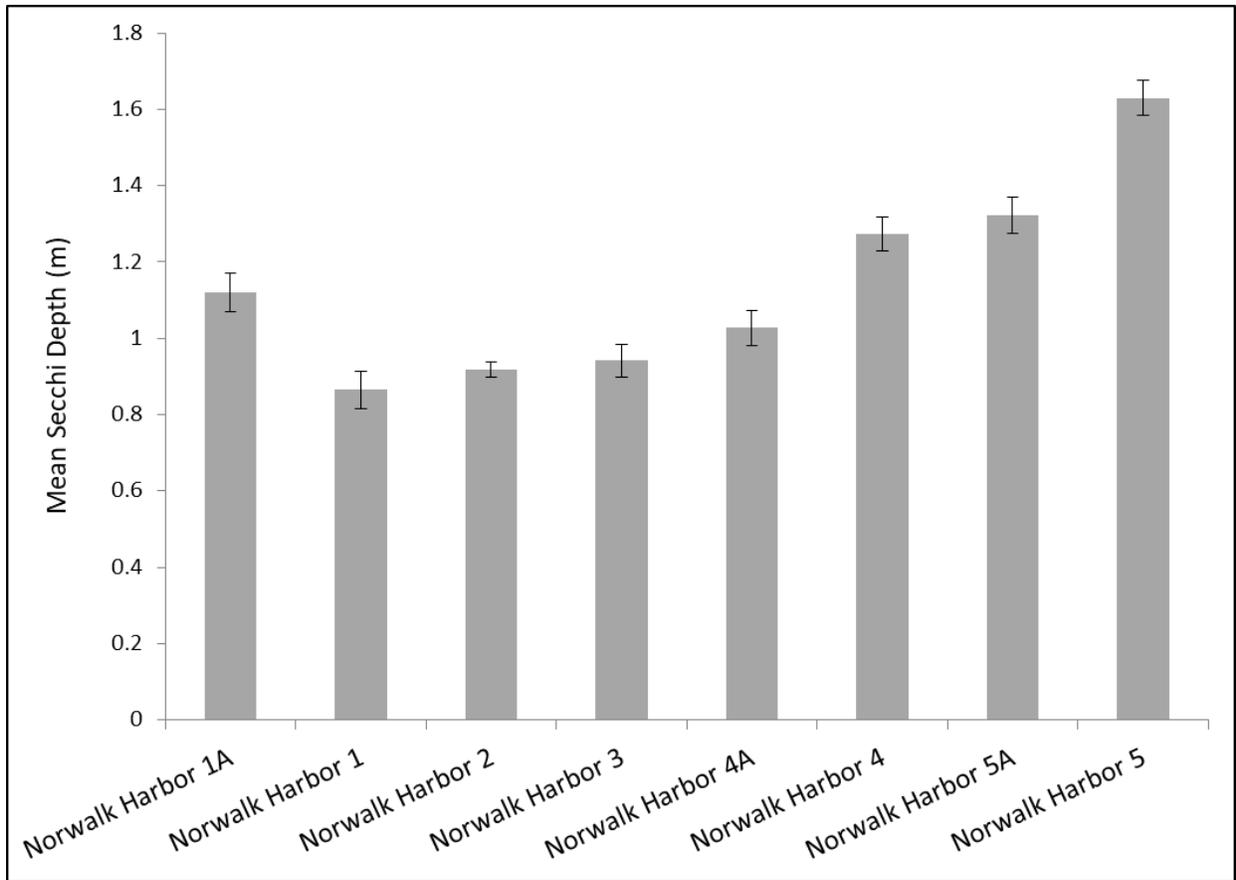
Figure 2.C.6. Mean secchi depth readings in Norwalk Harbor in 2022. Error bars represent standard error.

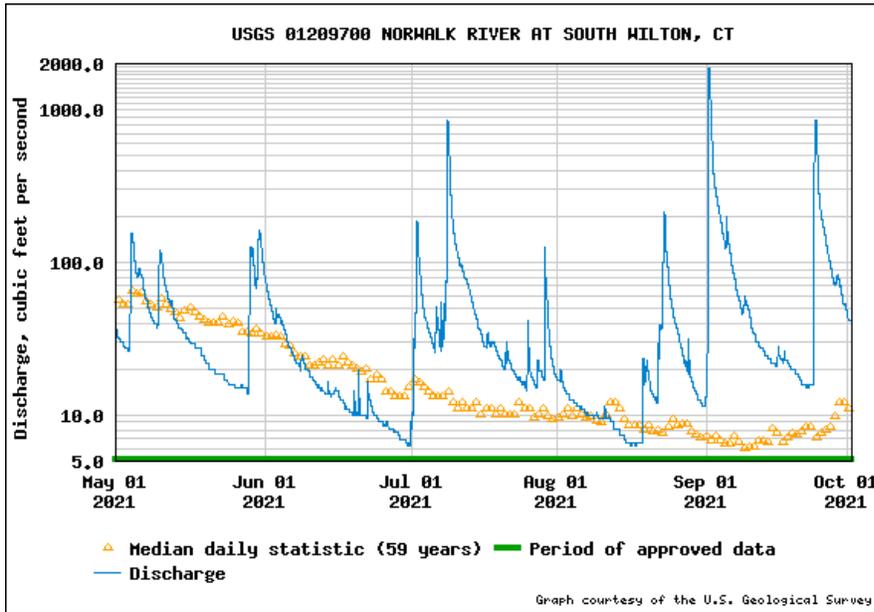
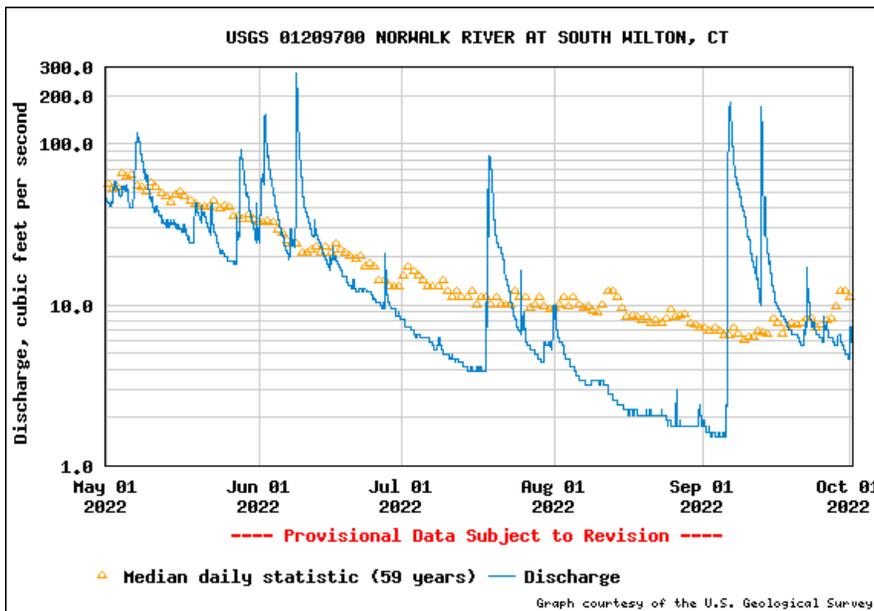
Figure 2.C.7. USGS flow data in ft³/s for the period of May 1 through October 1, 2021 (top) and 2022 (bottom), respectively for the Norwalk River in South Wilton, CT (Graph courtesy of the U.S. Geological Survey). Please note the difference in scale on the y-axis.

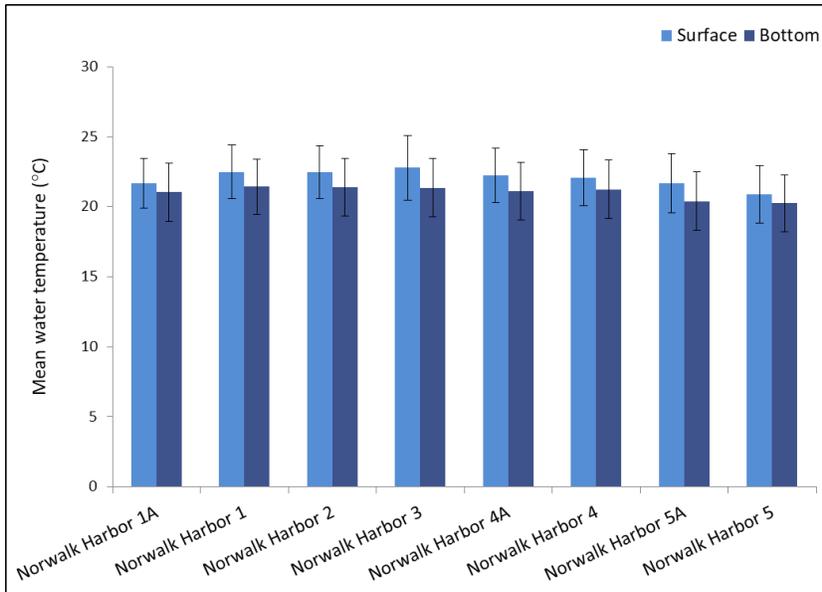
Figure 2.C.8. Mean water temperature at the surface and bottom at each sampling station in Norwalk Harbor in 2022. Error bars represent standard error.

Mean water temperature was consistent across all Norwalk Harbor stations (Figure 2.C.8). Salinity was lower at the surface than the bottom at all stations, with the largest difference observed at the inner harbor stations, reflecting the impact of the riverine inputs from the north where the harbor is less well mixed (Figure 2.C.9). This salinity stratification was the most pronounced at station Norwalk Harbor 1A, where the fresh water river discharge meets the toe of the tidal wedge.

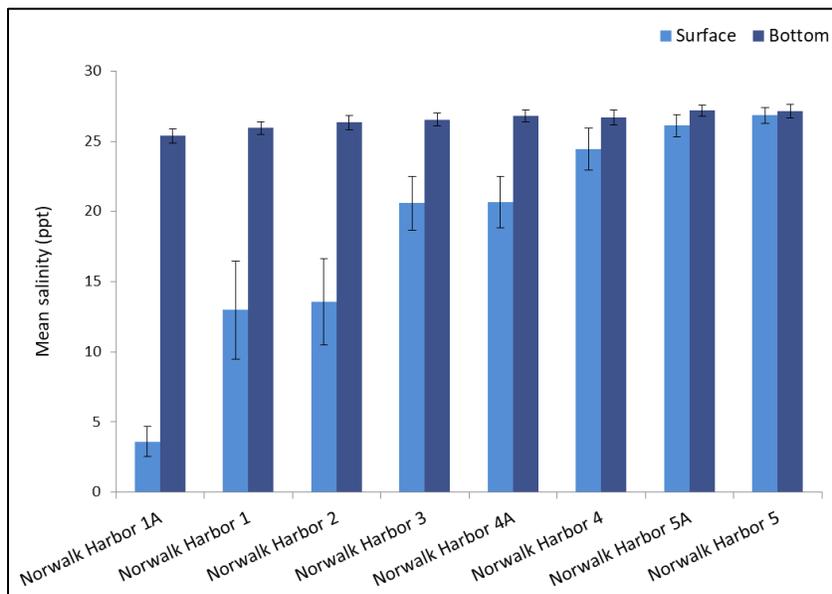
Figure 2.C.9. Mean salinity at the surface and bottom at each sampling station in Norwalk Harbor in 2022. Error bars represent standard error.

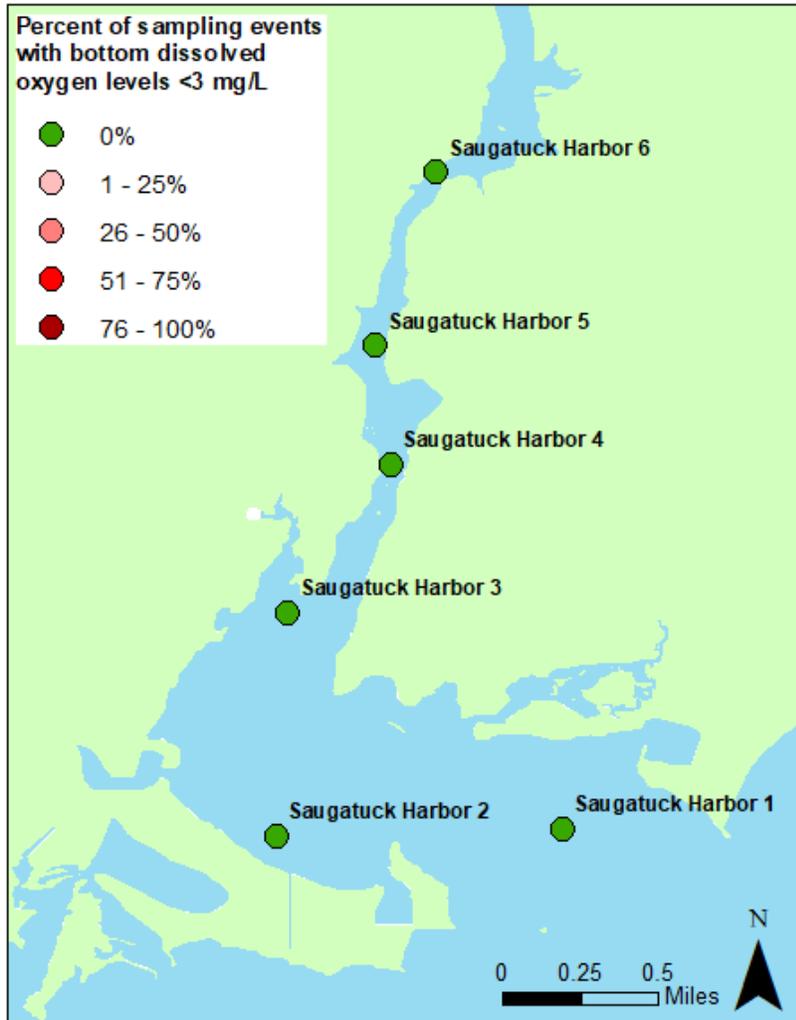
Figure 2.D.2. Map of Saugatuck Harbor sampling stations in 2022. Color of dots represents the percent of sampling events with dissolved oxygen levels less than 3 mg/L.

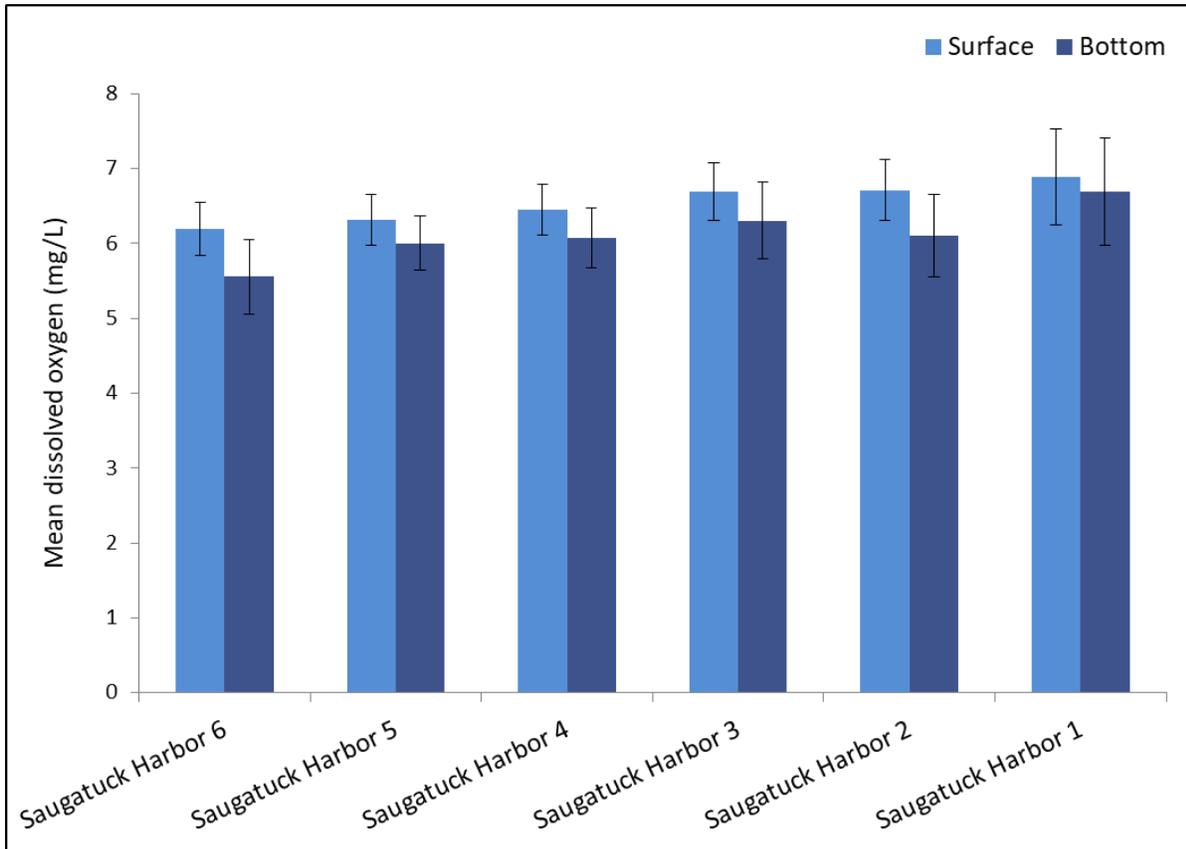
Figure 2.D.3. Mean dissolved oxygen concentrations at the surface and bottom at each sampling station in Saugatuck Harbor in 2022. Error bars represent standard error.

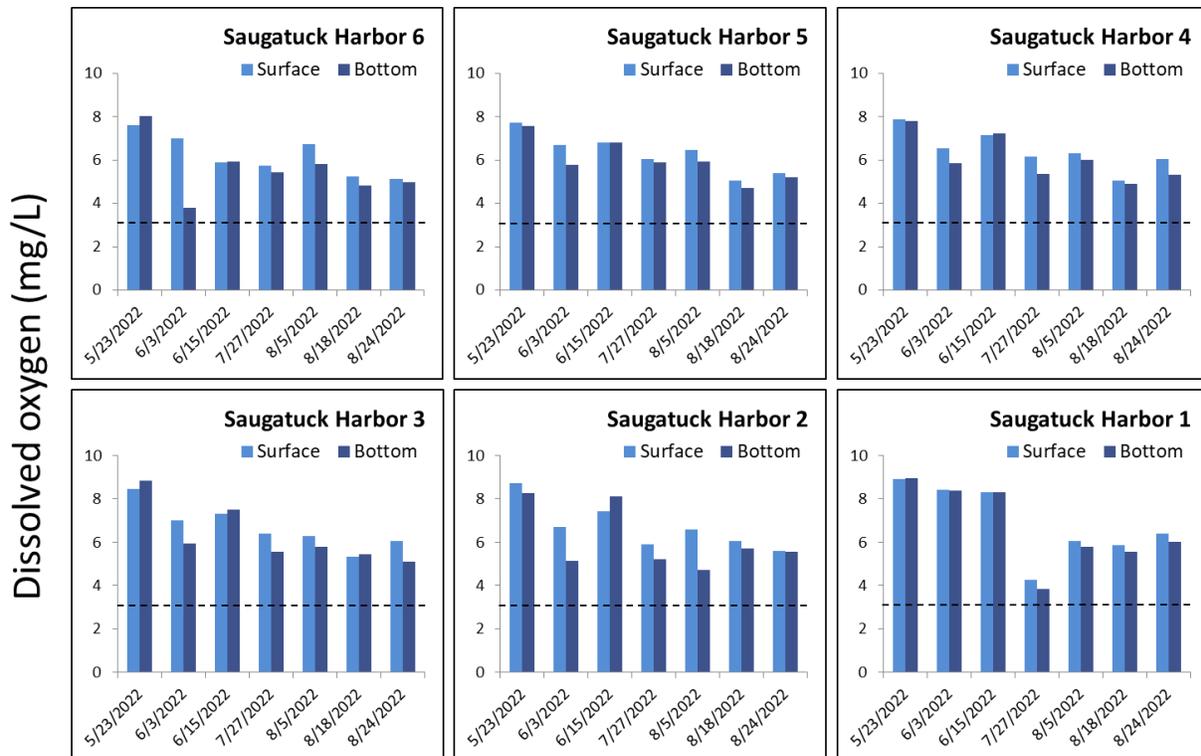
Figure 2.D.4. Surface and bottom dissolved oxygen values at each Saugatuck Harbor sampling station on each monitoring date during the 2022 season. The dotted line represents hypoxic conditions (3 mg/L). Please note x-axis is not to scale.

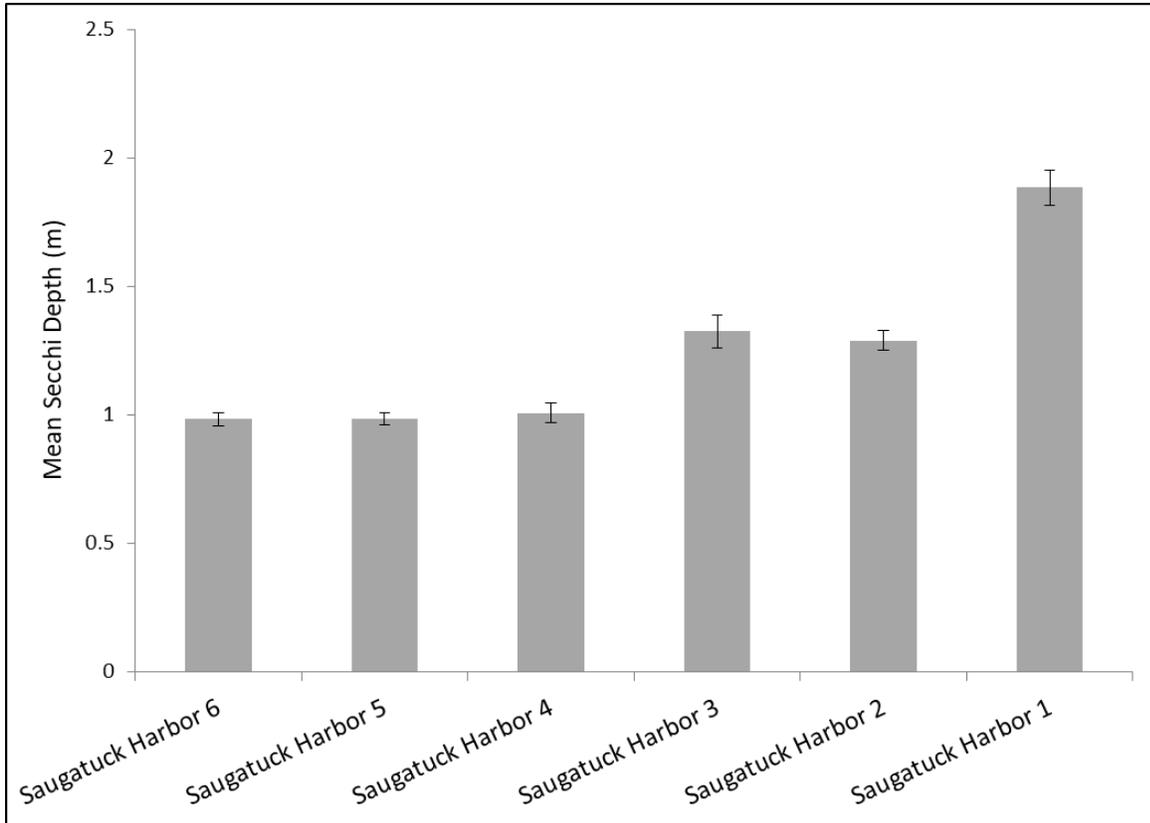
Figure 2.D.6. Mean secchi depth readings in Saugatuck Harbor in 2022. Error bars represent standard error.

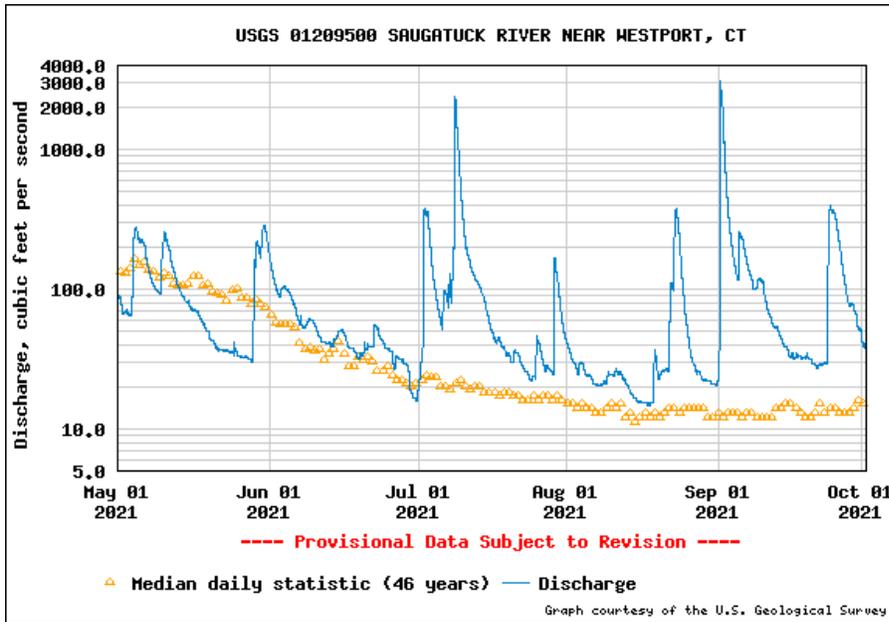
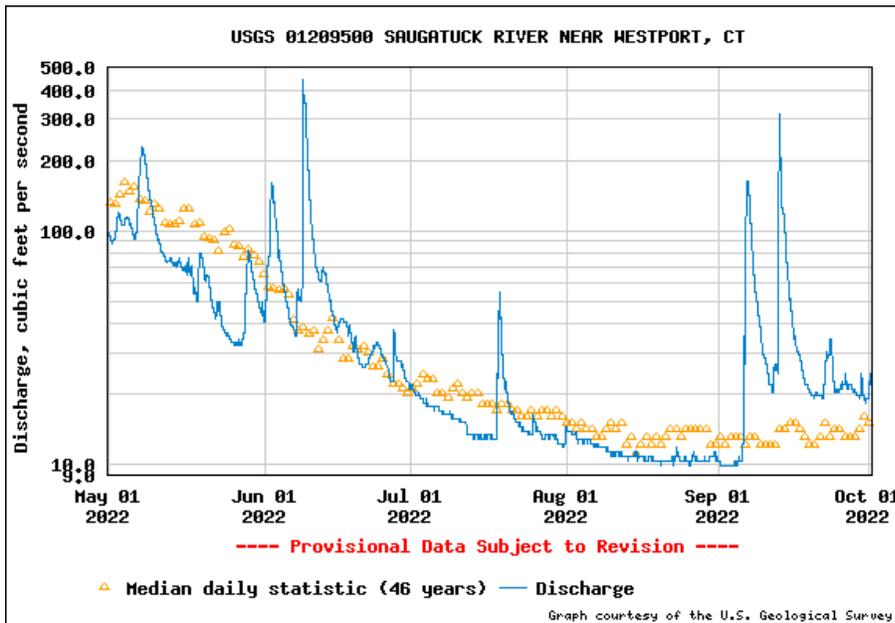
Figure 2.D.7. USGS flow data in ft^3/s for the period of May 1 through October 1 for the 2021 (top) and 2022 (bottom) respectively for the Saugatuck River near Westport, CT (Graphs courtesy of the U.S. Geological Survey). Please note the difference in scale on the y-axis.

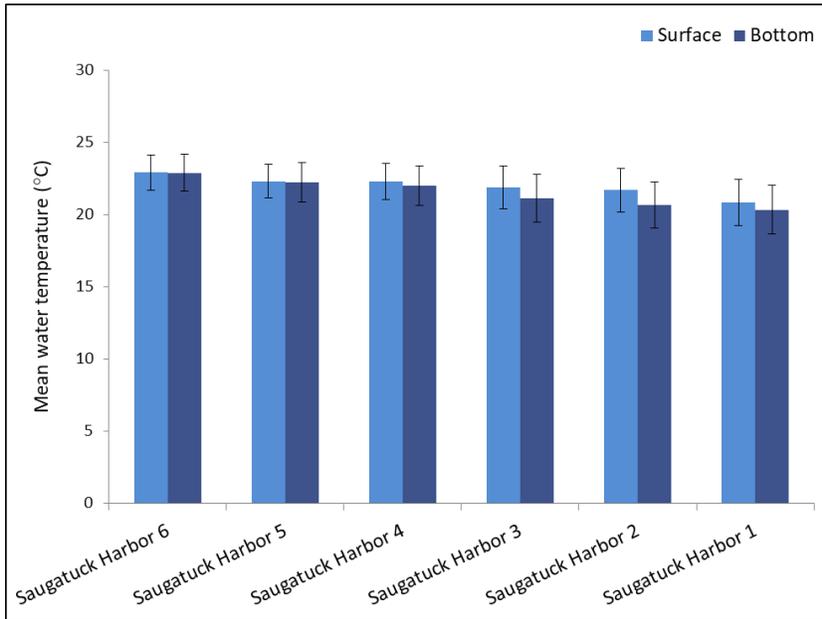
Figure 2.D.8. Mean water temperature at the surface and bottom at each sampling station in Saugatuck Harbor in 2022. Error bars represent standard error.

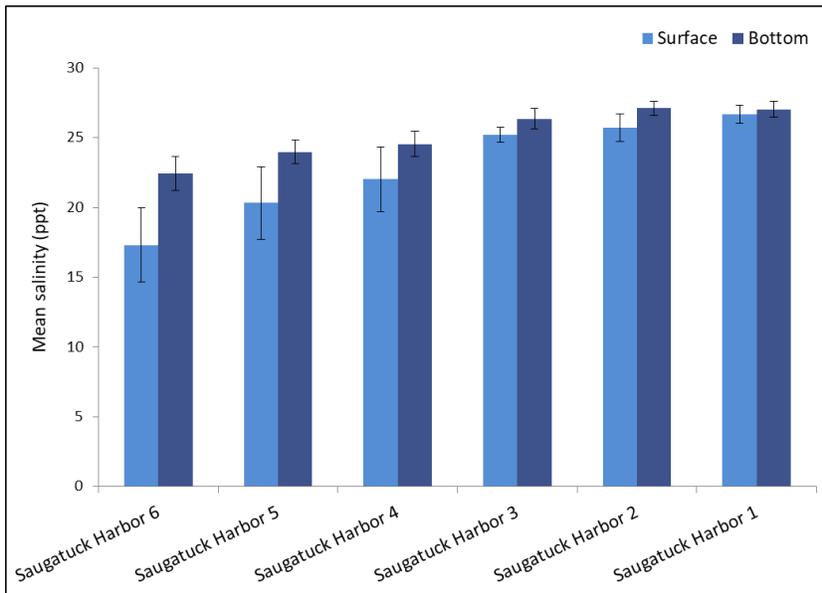
Figure 2.D.9. Mean salinity at the surface and bottom at each sampling station in Saugatuck Harbor in 2022. Error bars represent standard error.

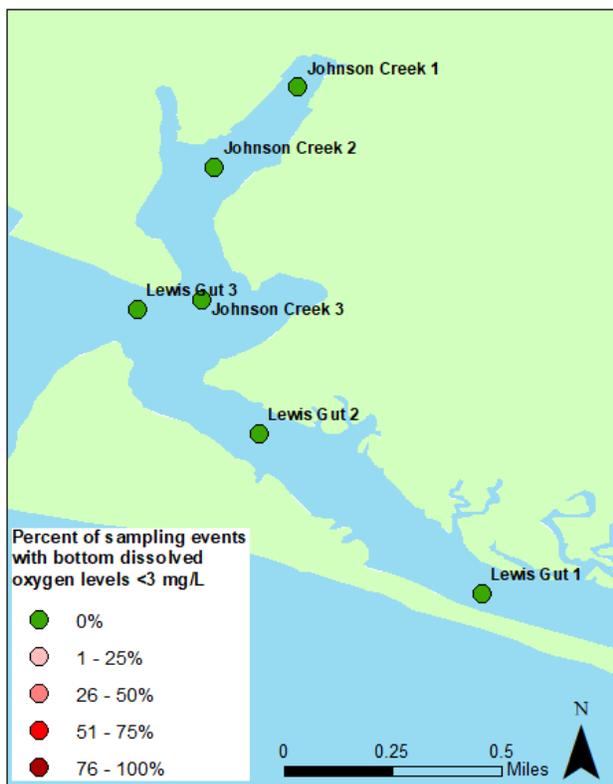
Figure 2.E.1. Map of Johnsons Creek and Lewis Gut sampling stations in 2022. Color of dots represents the percent of sampling events with dissolved oxygen levels less than 3 mg/L.

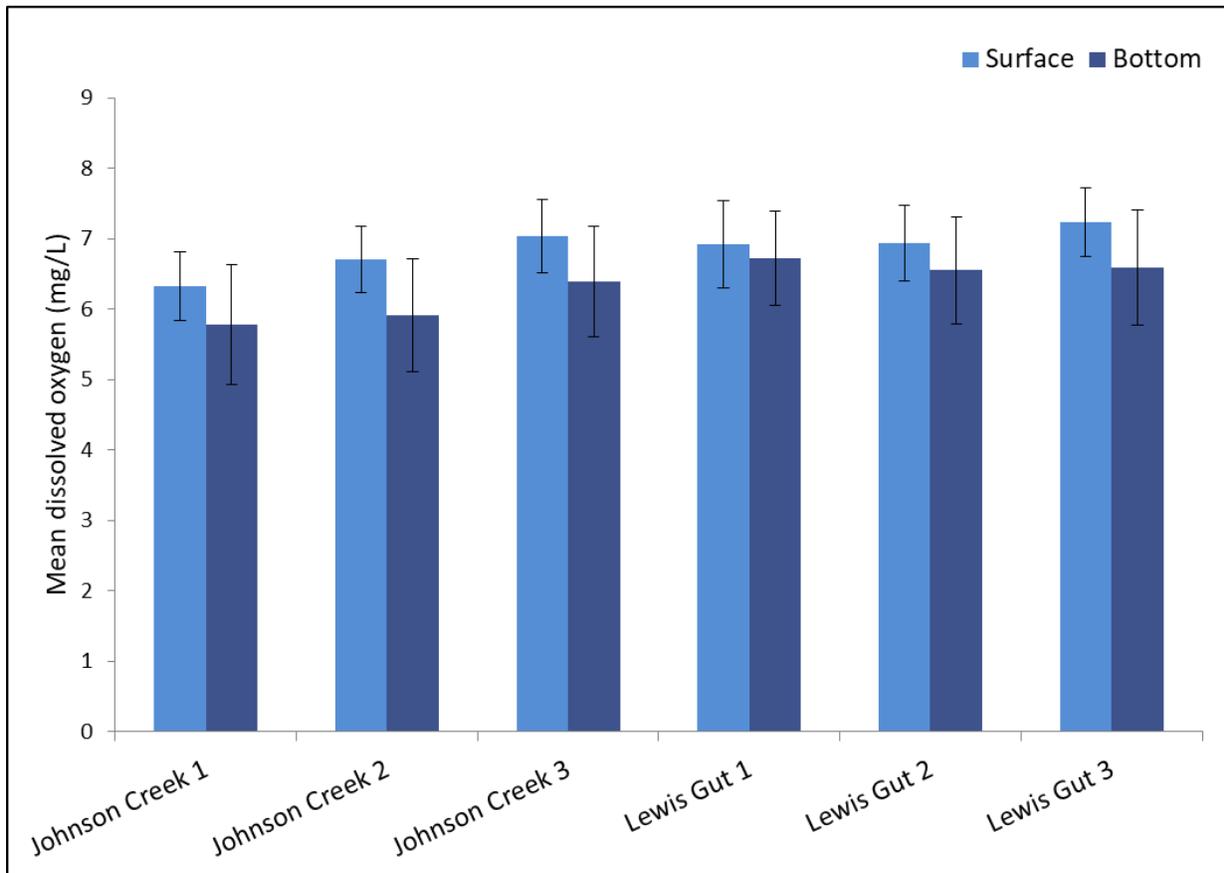
Figure 2.E.4. Mean dissolved oxygen concentrations at the surface and bottom at each sampling station in Johnsons Creek and Lewis Gut in 2022. Error bars represent standard error.

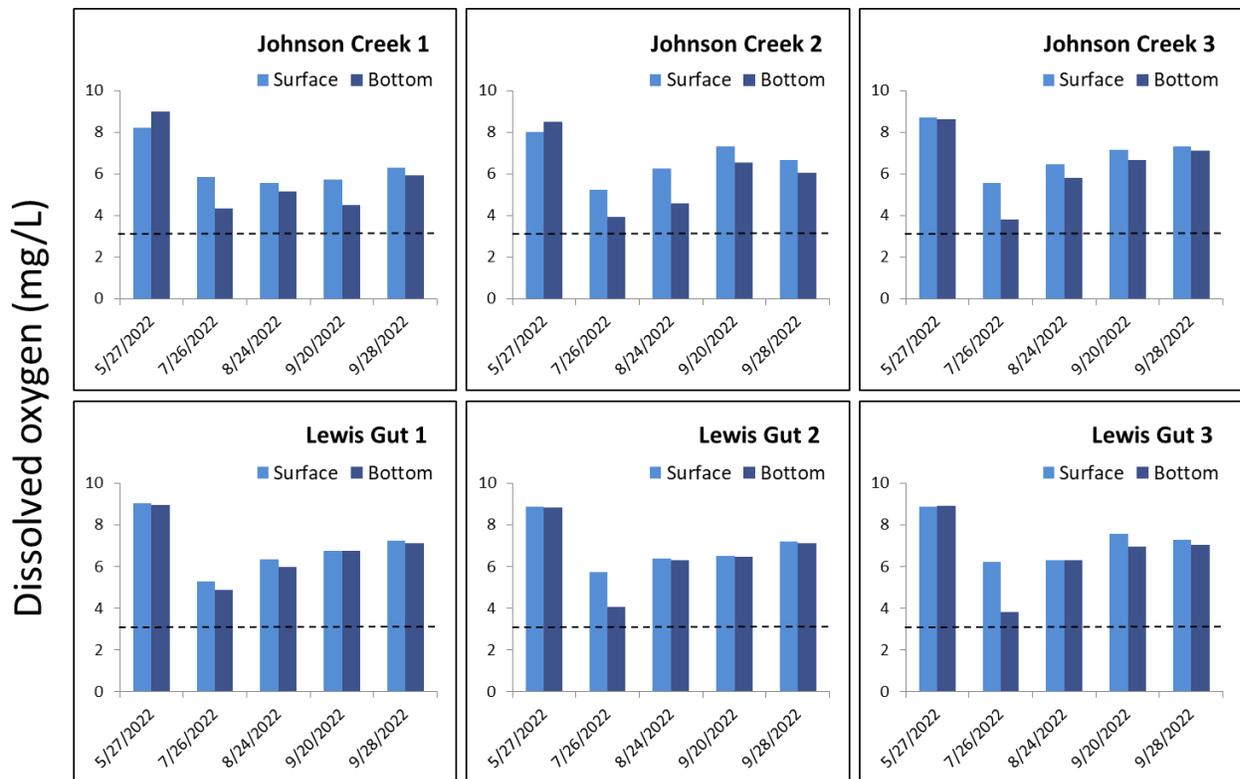
Figure 2.E.5. Surface and bottom dissolved oxygen values at each Johnsons Creek and Lewis Gut sampling station on each monitoring date during the 2022 season. The dotted line represents hypoxic conditions (3 mg/L). Please note x-axis is not to scale.

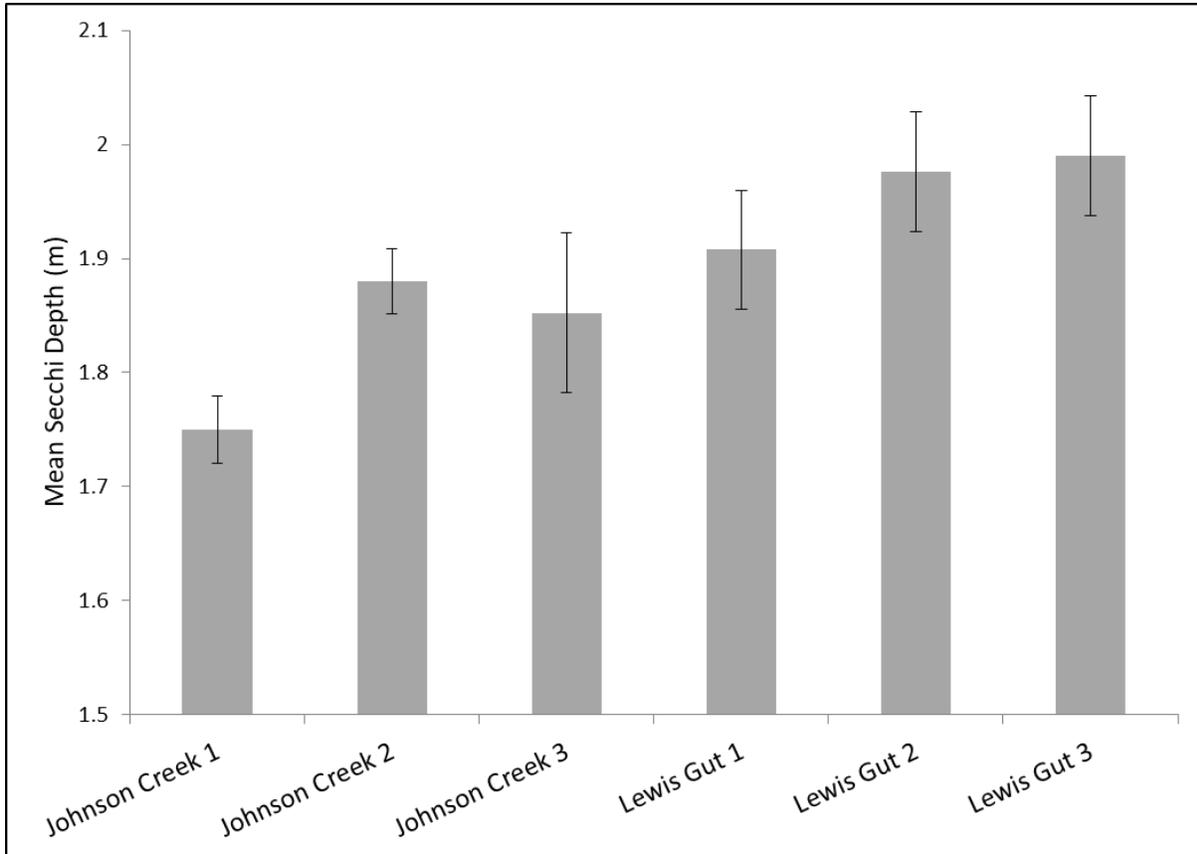
Figure 2.E.7. Mean secchi depth readings in the Johnsons Creek and Lewis Gut in 2022. Error bars represent standard error.

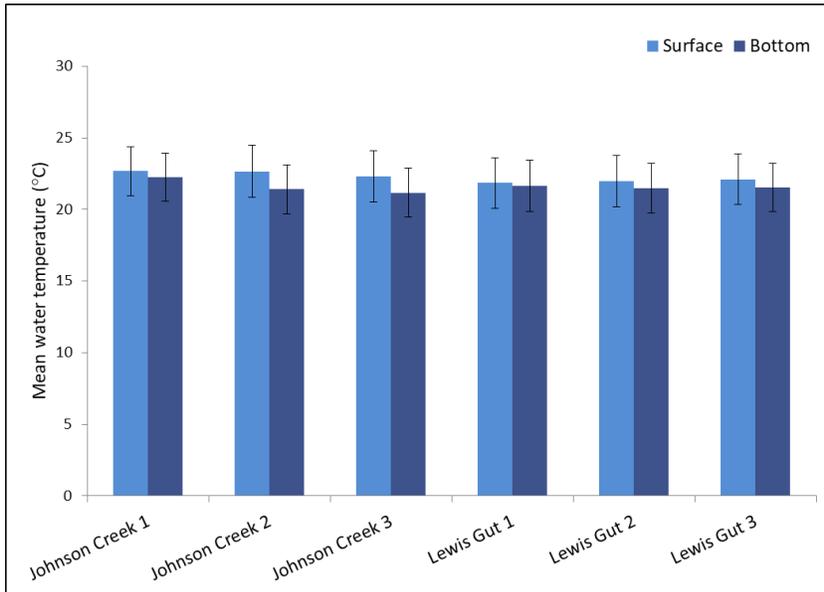
Figure 2.E.8. Mean water temperature at the surface and bottom at each sampling station in Johnsons Creek and Lewis Gut in 2022. Error bars represent standard error.

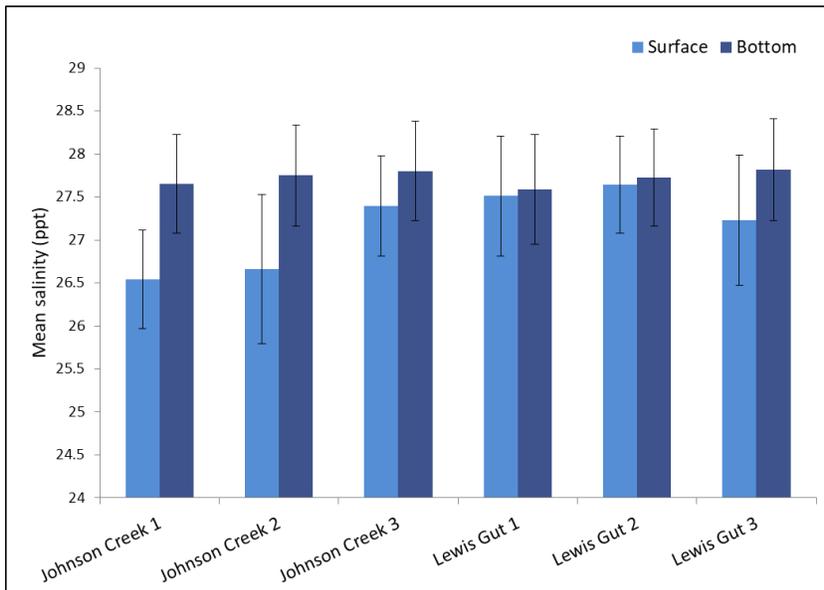
Figure 2.E.9. Mean salinity at the surface and bottom at each sampling station in Johnsons Creek and Lewis Gut in 2022. Error bars represent standard error.

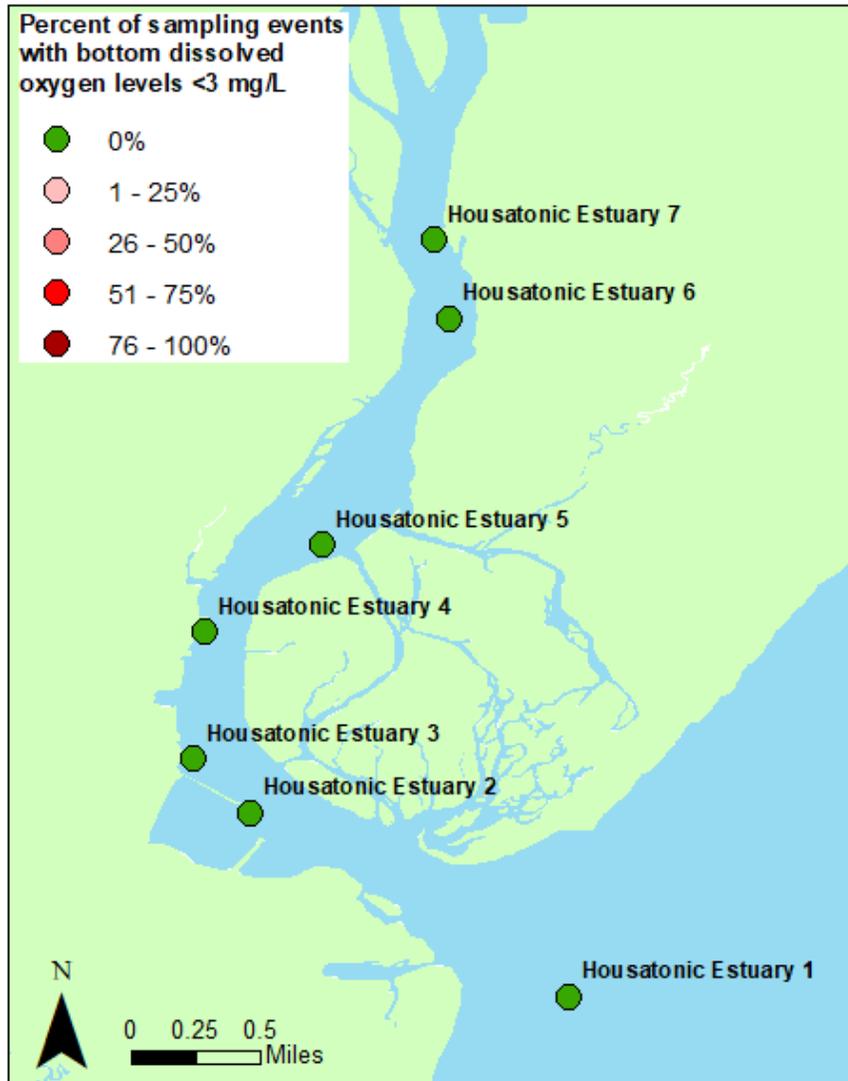
Figure 2.F.2. Map of Housatonic River sampling stations in 2022. Color of dots represents the percent of sampling events with dissolved oxygen levels less than 3 mg/L.

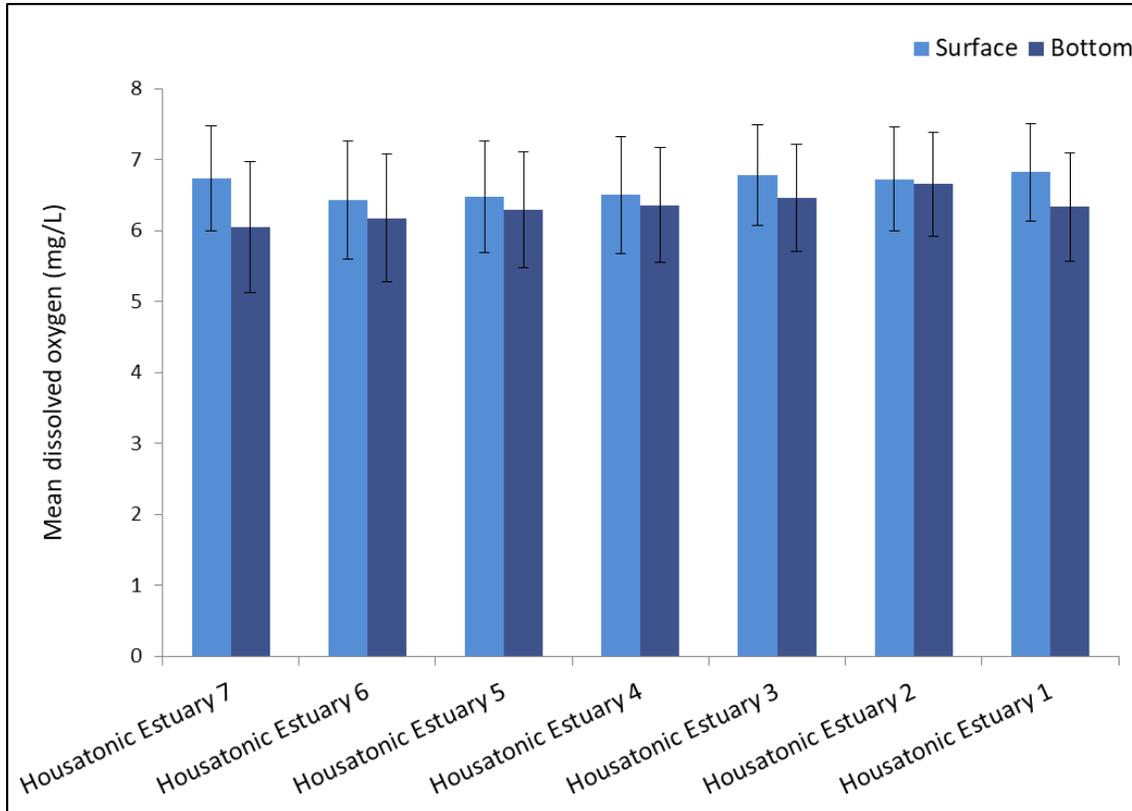
Figure 2.F.3. Mean dissolved oxygen concentrations at the surface and bottom at each sampling station in the Housatonic River in 2022. Error bars represent standard error.

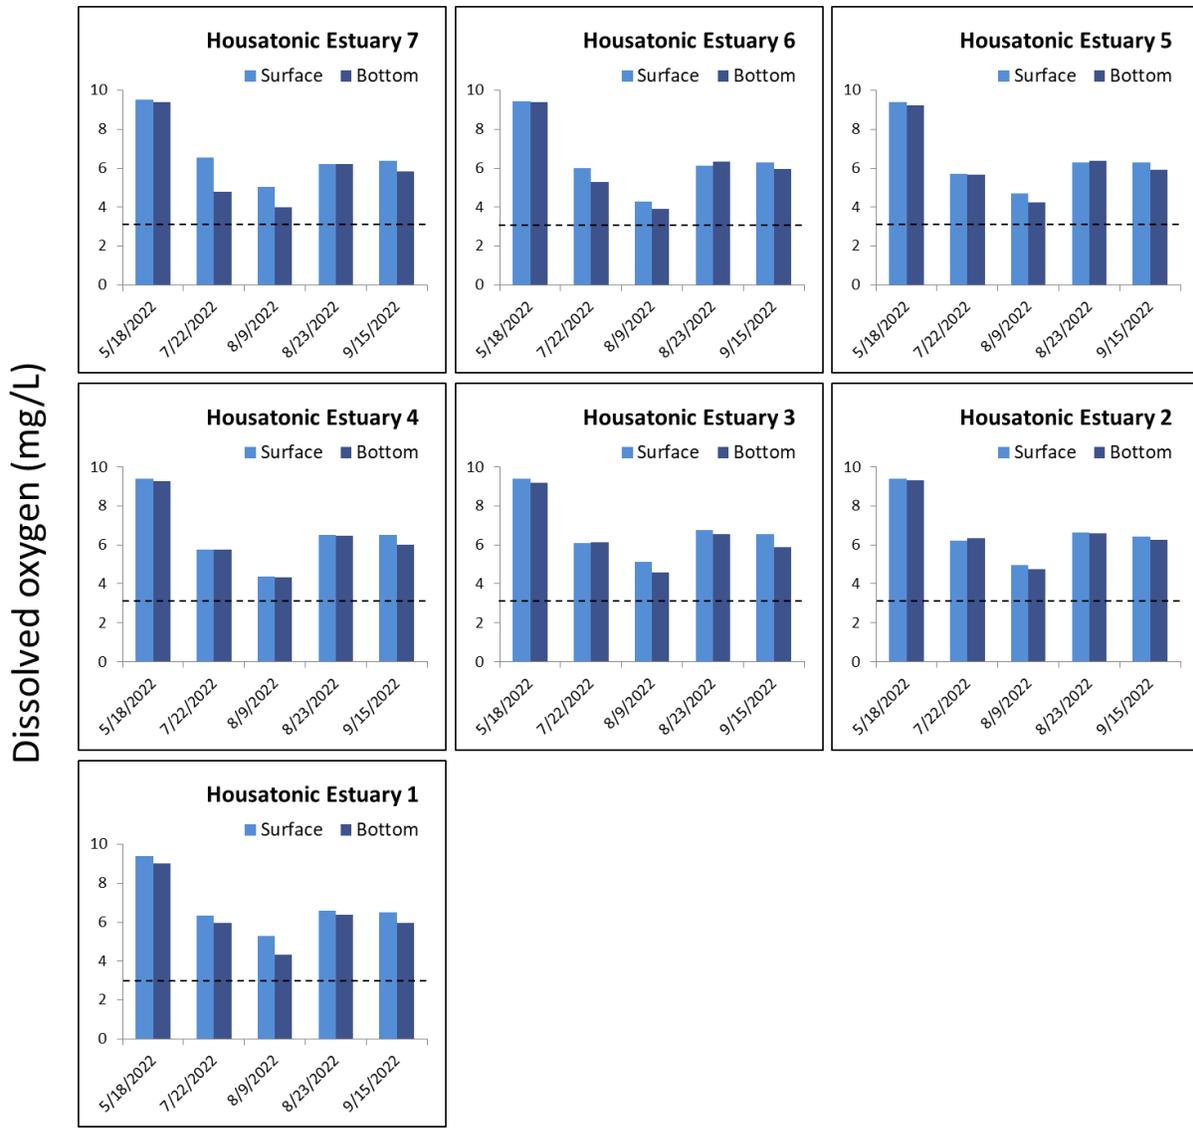
Figure 2.F.4. Surface and bottom dissolved oxygen values at each Housatonic River sampling station on each monitoring date during the 2022 season. The dotted line represents hypoxic conditions (3 mg/L). Please note x-axis is not to scale.

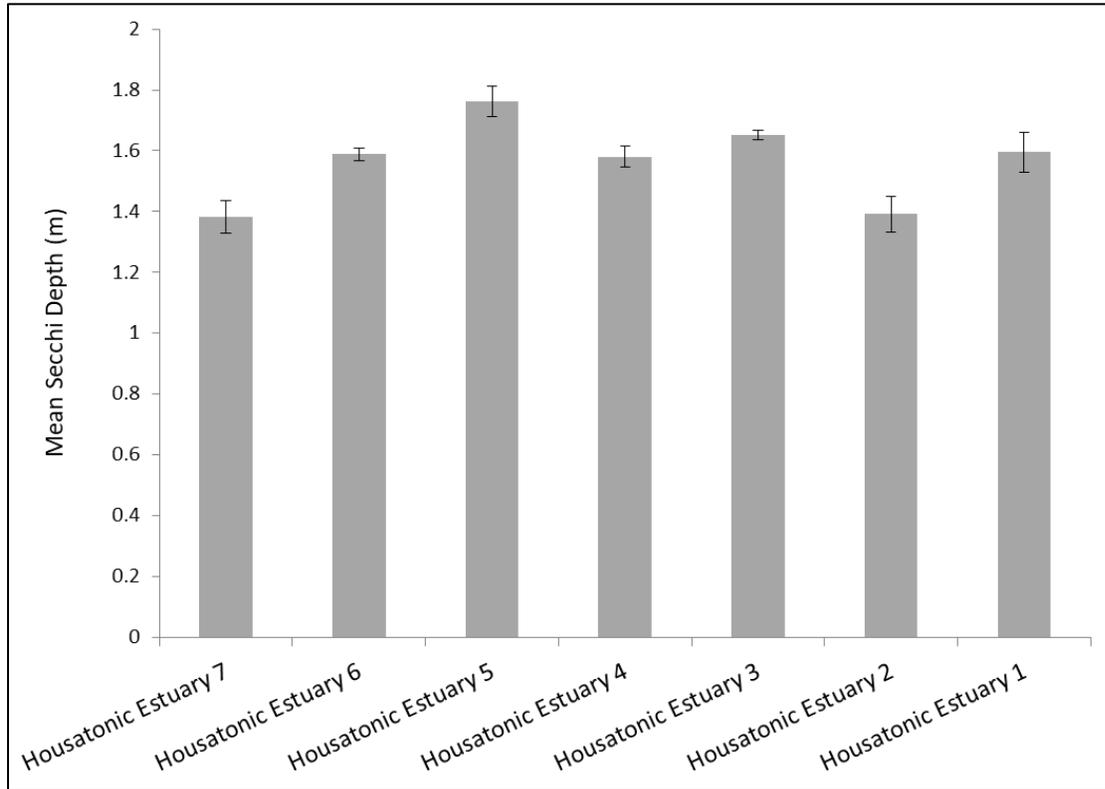
Figure 2.F.6. Mean secchi depth readings in the Housatonic Estuary in 2022. Error bars represent standard error.

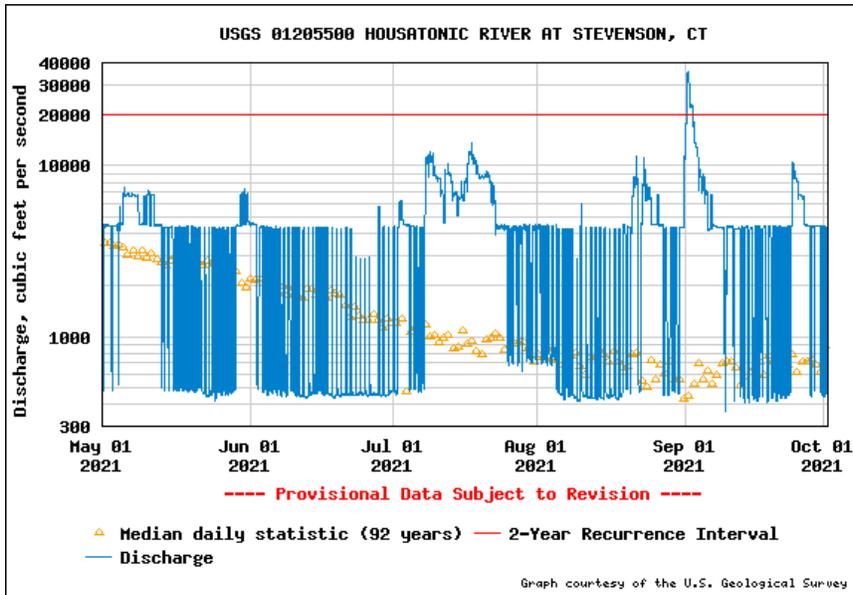
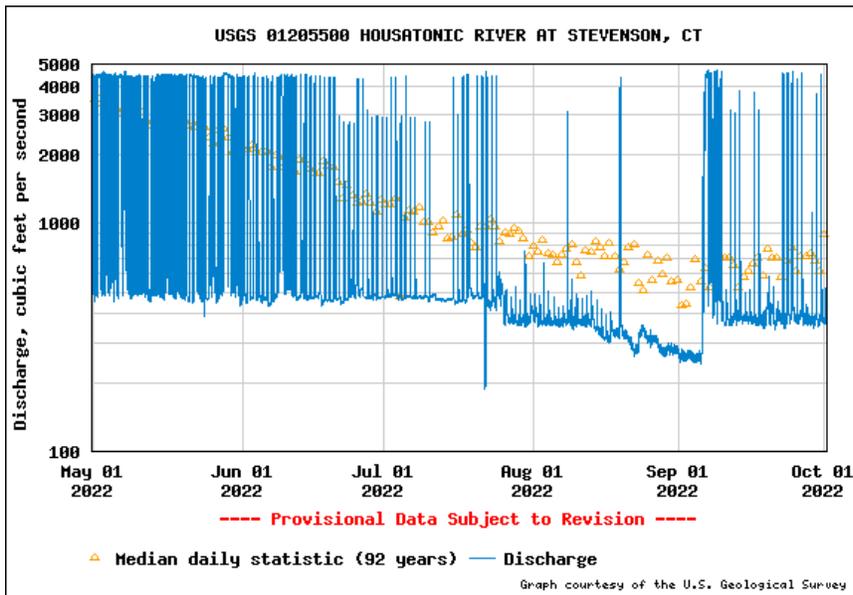
Figure 2.F.7. USGS flow data in ft^3/s for the period of May 1 through October 1, 2021 (top) and 2022 (bottom), respectively for the Housatonic River in Stevenson, CT (Graphs courtesy of the U.S. Geological Survey). Please note the difference in scale on the y-axis.
