HARBOR HEALTH STUDY

Harbor Health Study: 2022

*The Harbor Health Study is a collaborative effort between **Harbor Watch, Copsps Island Oysters, and East Norwalk Blue** to collect data on the ecosystem health of local embayments.*

This report includes data on:

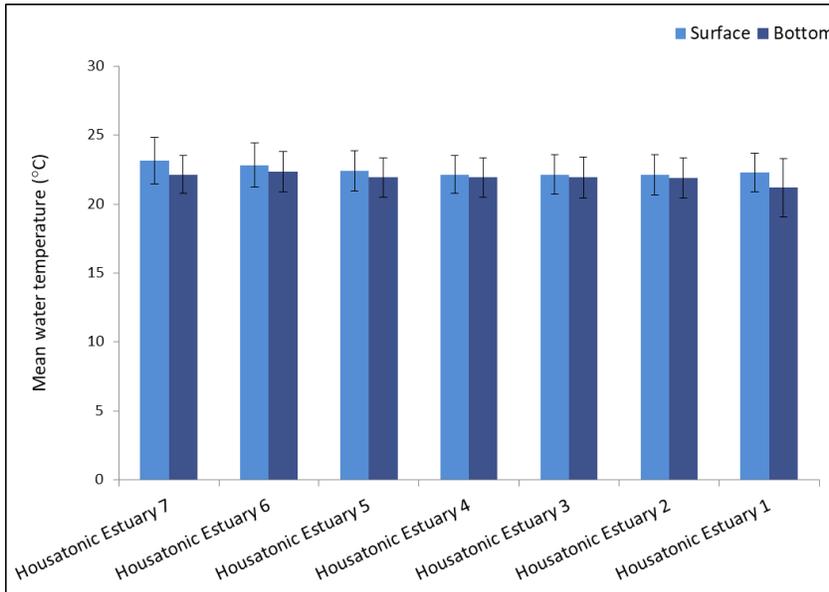
Figure 2.F.8. Mean water temperature at the surface and bottom at each sampling station in the Housatonic Estuary in 2022. Error bars represent standard error.

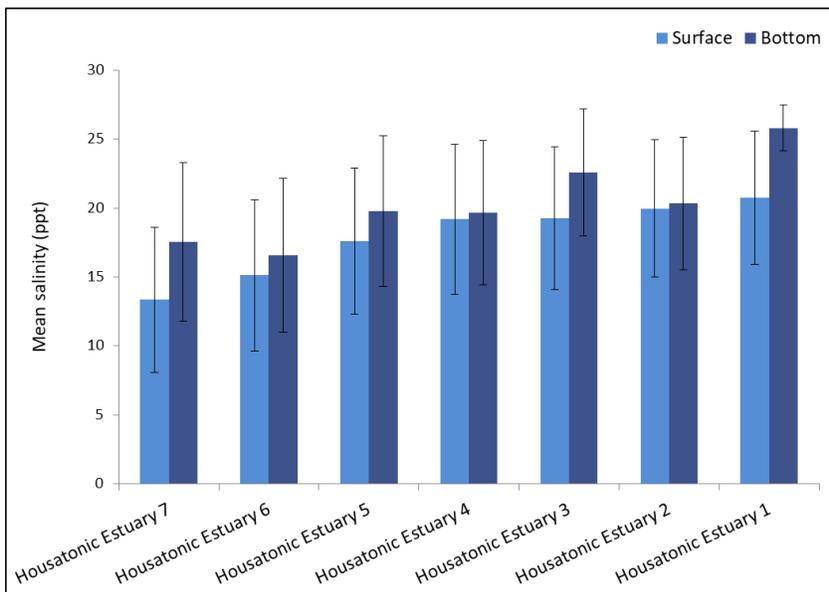
Figure 2.F.9. Mean salinity at the surface and bottom at each sampling station in the Housatonic Estuary in 2022. Error bars represent standard error.

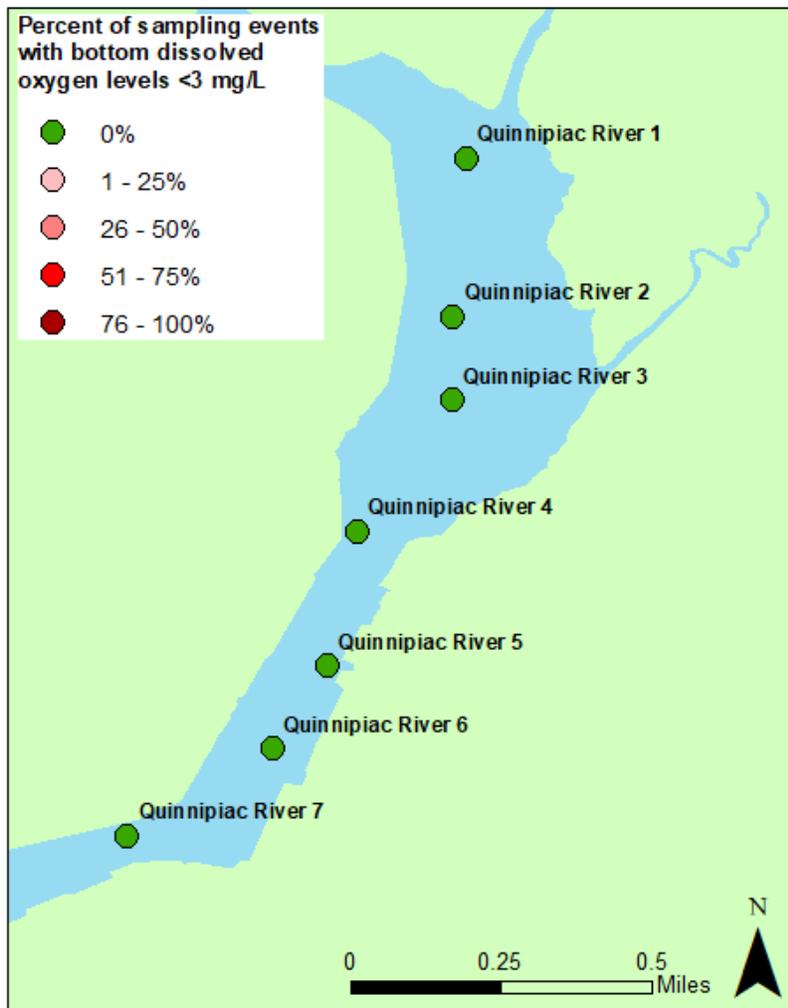
Figure 2.G.2. Map of Quinnipiac River sampling stations in 2022. Color of dots represents the % of sampling events with dissolved oxygen levels less than 3 mg/L.

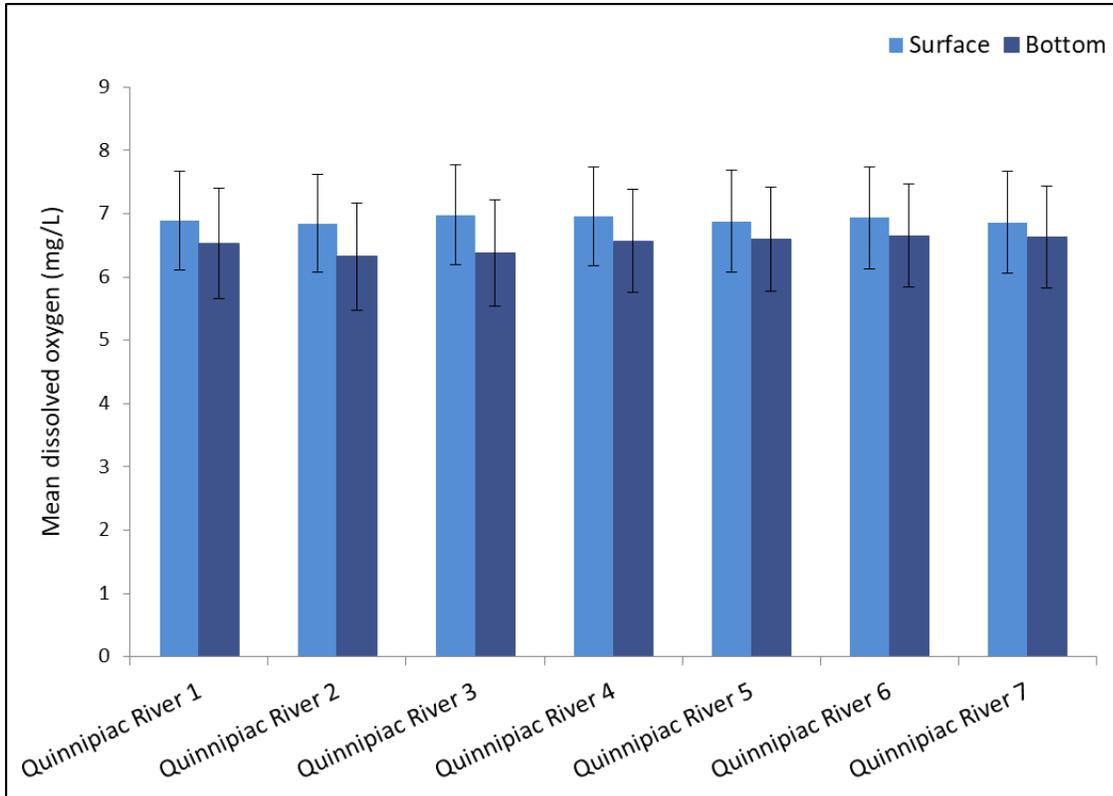
Figure 2.G.3. Mean dissolved oxygen concentrations at the surface and bottom at each sampling station in the Quinnipiac River in 2022. Error bars represent standard error.

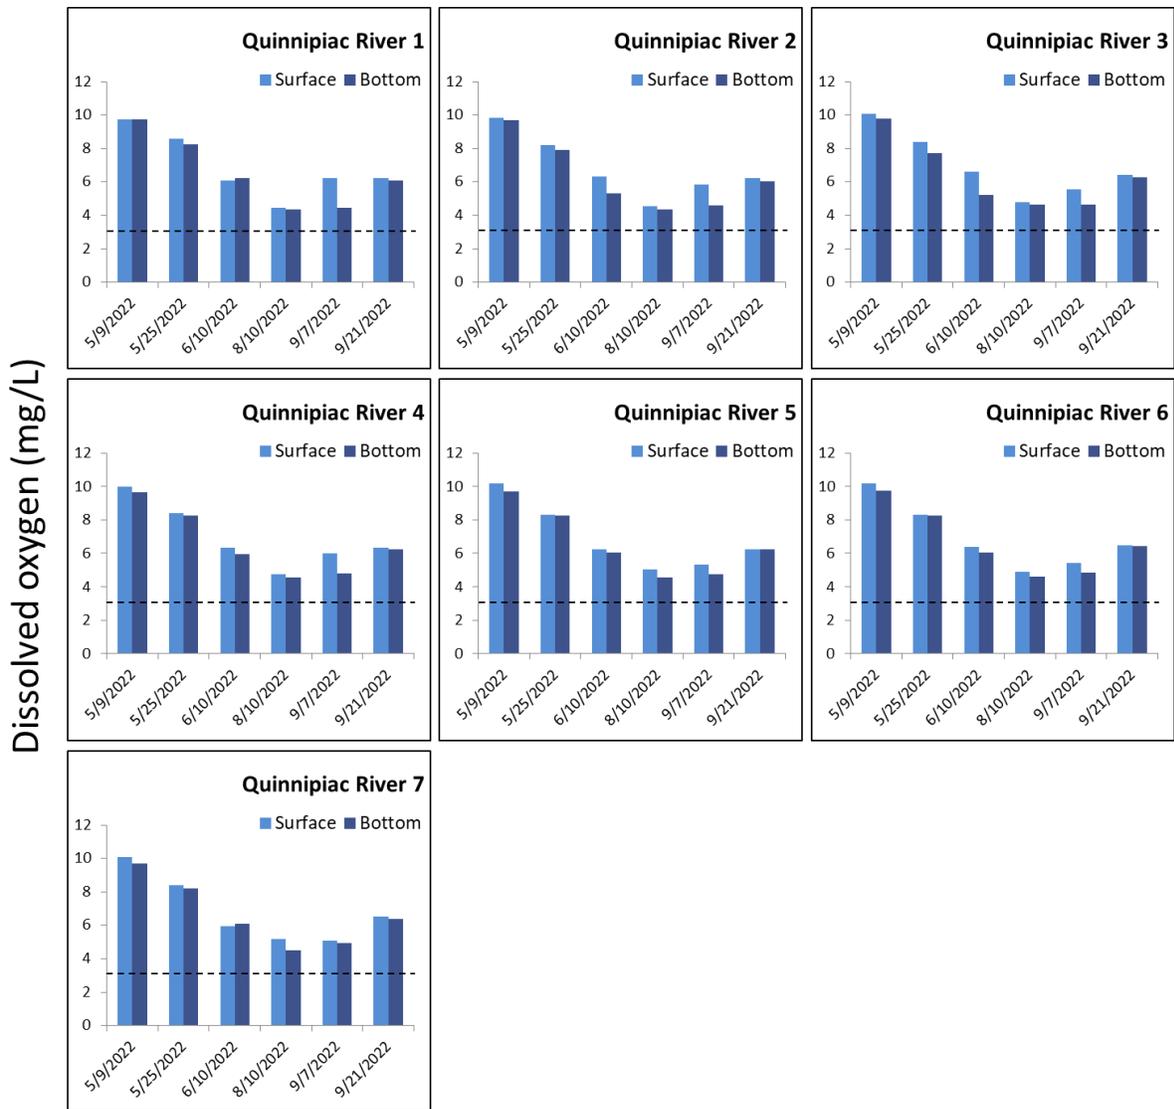
Figure 2.G.4. Surface and bottom dissolved oxygen values at each Quinnipiac River sampling station on each monitoring date during the 2022 season. The dotted line represents hypoxic conditions (3 mg/L). Please note x-axis is not to scale.

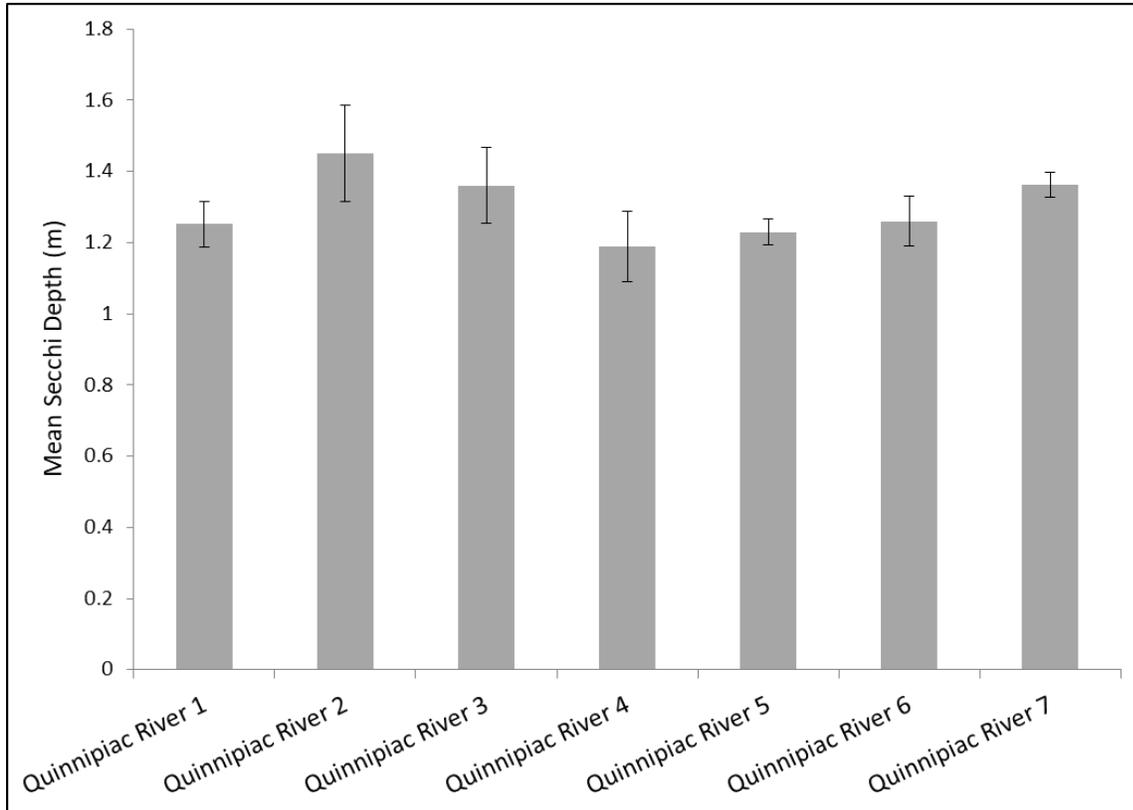
Figure 2.G.6. Mean secchi depth readings in the Quinnipiac River in 2022. Error bars represent standard error.

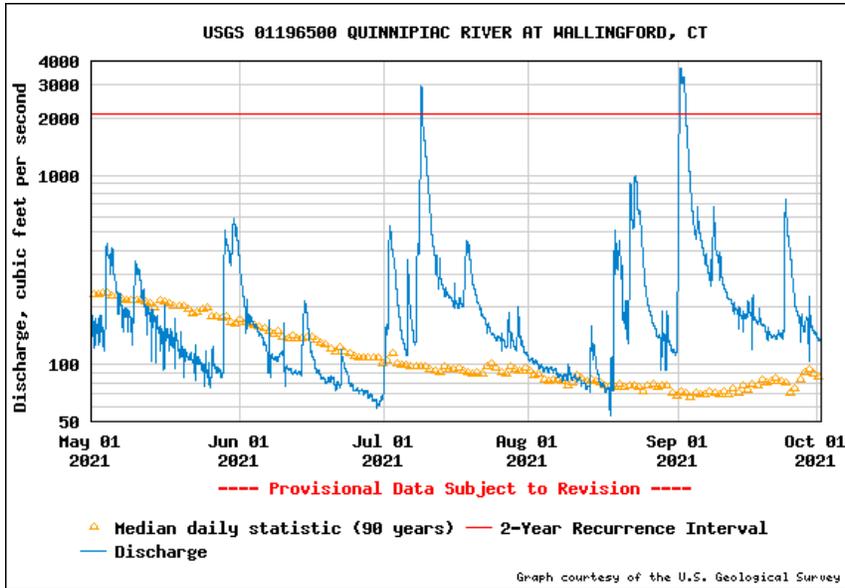
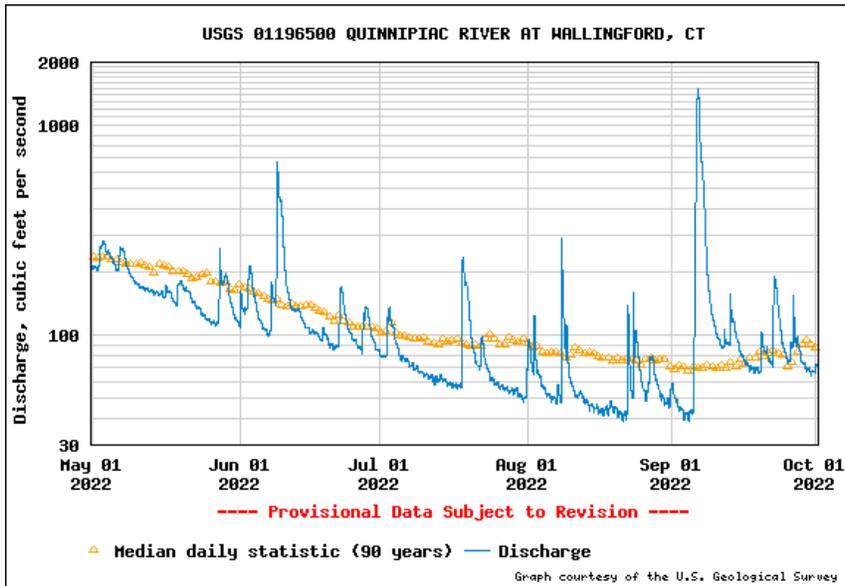
Figure 2.G.7. USGS flow data in ft^3/s for the period of May 1 through October 1, 2021 (top) and 2022 (bottom), respectively for the Quinnipiac River in Wallingford, CT (Graphs courtesy of the U.S. Geological Survey). Please note the difference in scale on the y-axis.

The figures below illustrate discharge in cubic feet per second recorded at the United States Geological Survey monitoring station on the Quinnipiac River in Wallingford, CT. Yellow triangles represent the daily median value over the last 90 years, and the blue line represents the recorded discharge for a particular date. During 2021, the watershed experienced numerous and large precipitation events specifically from July through September which caused discharge to be much higher than what was observed in 2022 as well as against the median daily statistic.

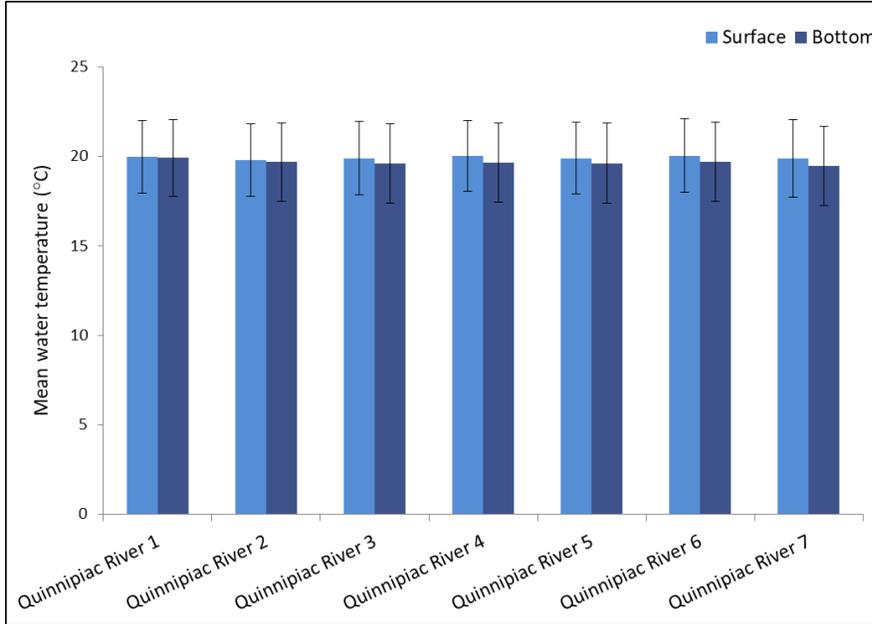
Figure 2.G.8. Mean water temperature at the surface and bottom at each sampling station in the Quinnipiac River in 2022. Error bars represent standard error.

Mean water temperature in the Quinnipiac River was observed to be similar throughout the water column in 2022 (Figure 2.G.8). Salinity was slightly lower at the surface than the bottom at all stations due to fresh surface water from the Quinnipiac River (Figure 2.G.9).

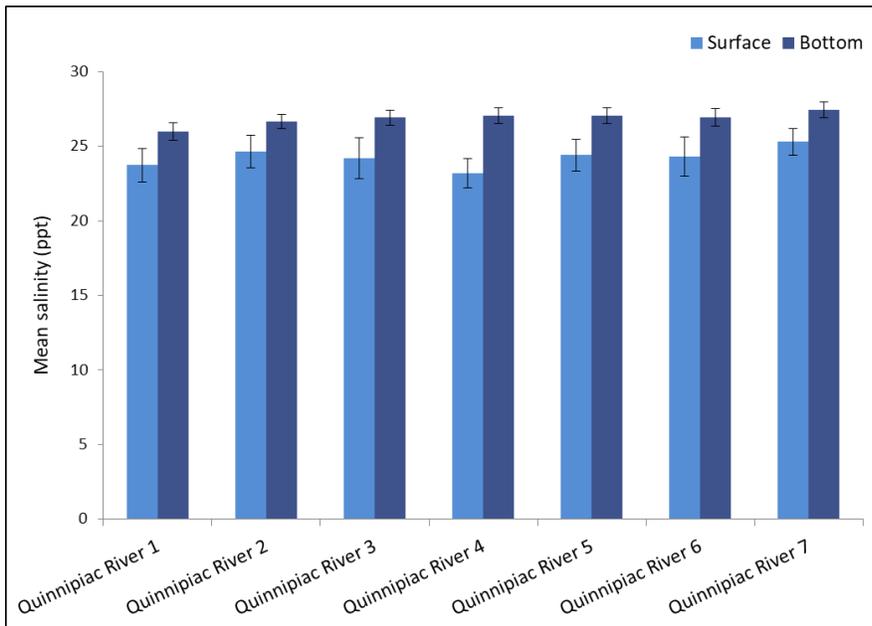
Figure 2.G.9. Mean salinity at the surface and bottom at each sampling station in the Quinnipiac River in 2022. Error bars represent standard error.
