HARBOR HEALTH STUDY

2023

Harbor Health Study: 2023

*The Harbor Health Study is a collaborative effort between **Harbor Watch, Copsps Island Oysters, and East Norwalk Blue** to collect data on the ecosystem health of local embayments.*

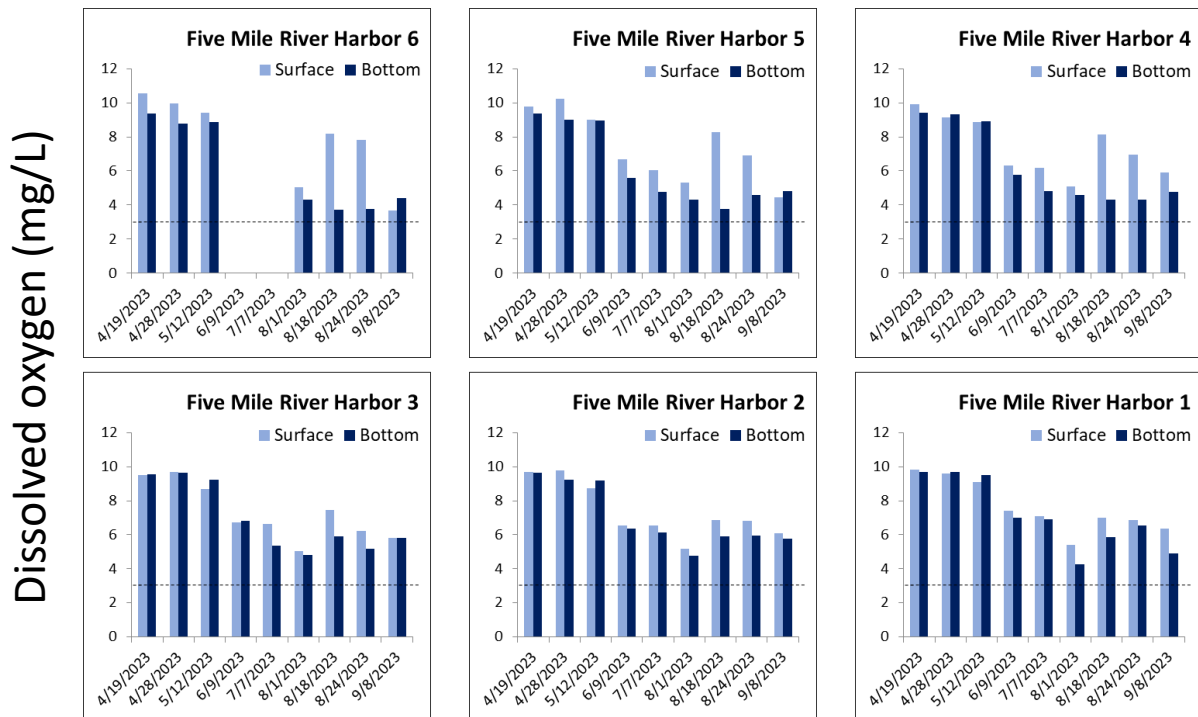
Figure B2.3. Surface and bottom dissolved oxygen values at each Five Mile River Harbor sampling station on each monitoring date during the 2023 season. The dotted line represents hypoxic conditions (3 mg/L). Station Five Mile River Harbor 6 was not sampled on 6/9/2023 and 7/7/2023 due to inaccessibility. Please note x-axis is individual sampling dates, not a time scale.

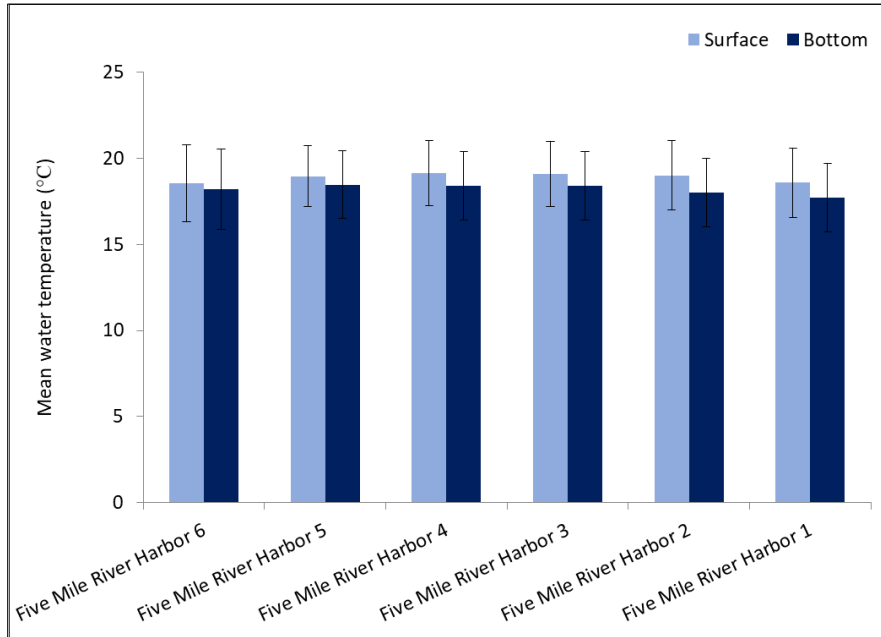
Figure B2.4. Mean water temperature at the surface and bottom at each sampling station in Five Mile River Harbor in 2023. Error bars represent standard error.

Mean surface and bottom water temperature in Five Mile River Harbor were similar throughout the harbor (Figure B2.4). Lower salinity observed at the surface in the landward end of the estuary reflects the impact of Five Mile River input from the north and Indian Creek input upstream of Five Mile Harbor 5, where the harbor is less well mixed (Figure B2.1, Figure B2.5).

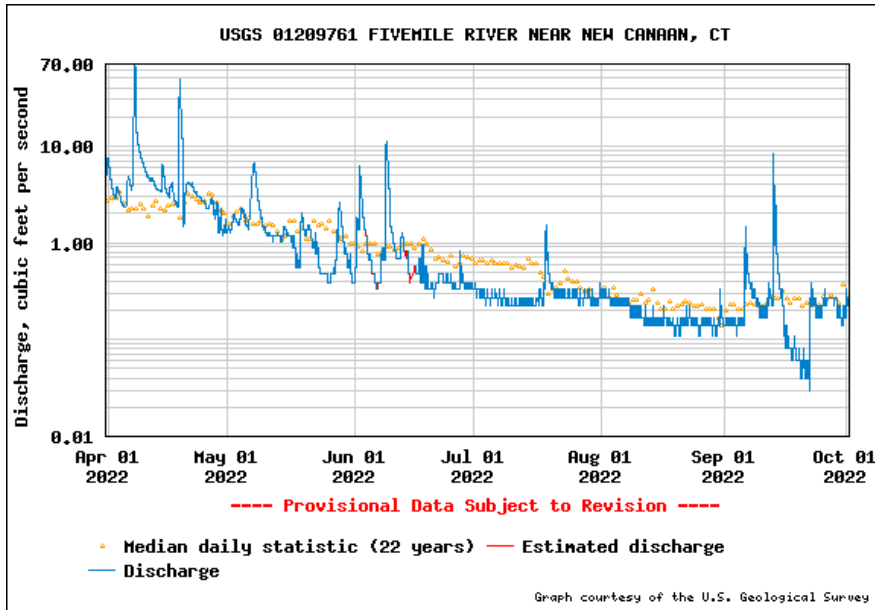
Figure B2.7. USGS flow data in ft^3/s for the period of April 1 through October 1, 2022 (top) and 2023 (bottom), respectively for the Five Mile River in New Canaan, CT (Graph courtesy of the U.S. Geological Survey). Please note the difference in scale on the y-axis.

The figures below illustrate discharge rates (cubic feet per second) recorded at the United States Geological Survey monitoring station on the Five Mile River in New Canaan, CT. Yellow triangles represent the daily median value over the last 22 years, and the blue line represents the recorded discharge for a particular date. In 2023, frequent rain events increased discharge often from July through October while discharge was observed to be lower in 2022, and often below the median.

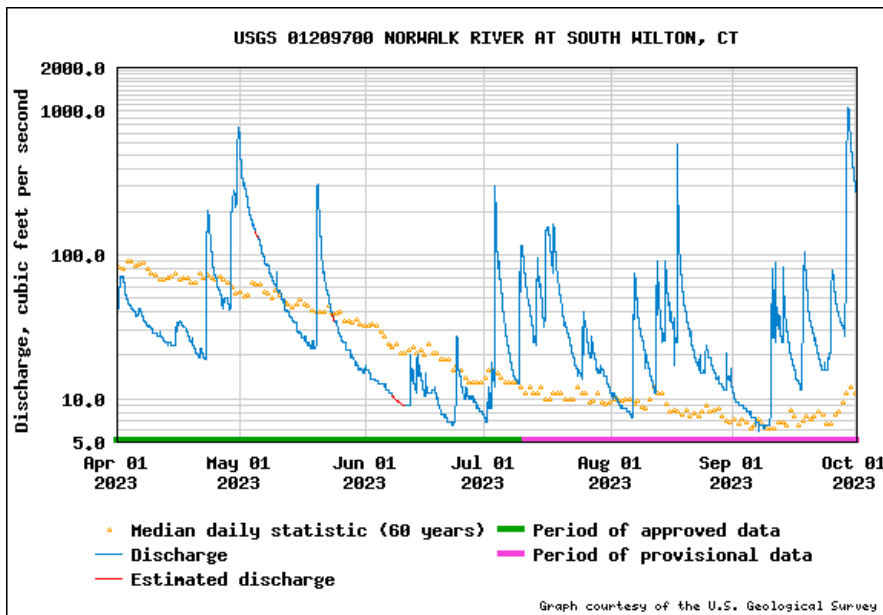
Figure B3.8. USGS flow data in ft³/s for the period of April 1 through October 1, 2022 (top) and 2023 (bottom), respectively for the Norwalk River in South Wilton, CT (Graph courtesy of the U.S. Geological Survey). Please note the difference in scale on the y-axis.
